Residential aged care services built environment audit tool

Online version 1.2: Part 5. Photo gallery

5. Photo gallery

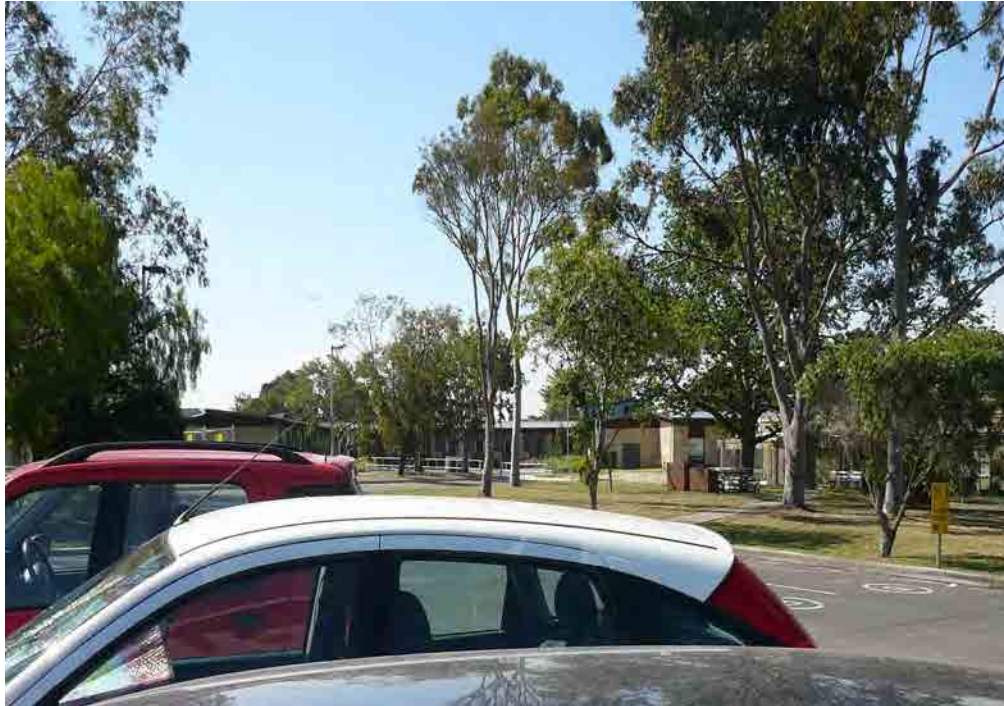
Recommendation 3 – parking

There is a drop off area at the entrance to this RACS, but the car park is much further away and quite a distance for older visitors to walk.

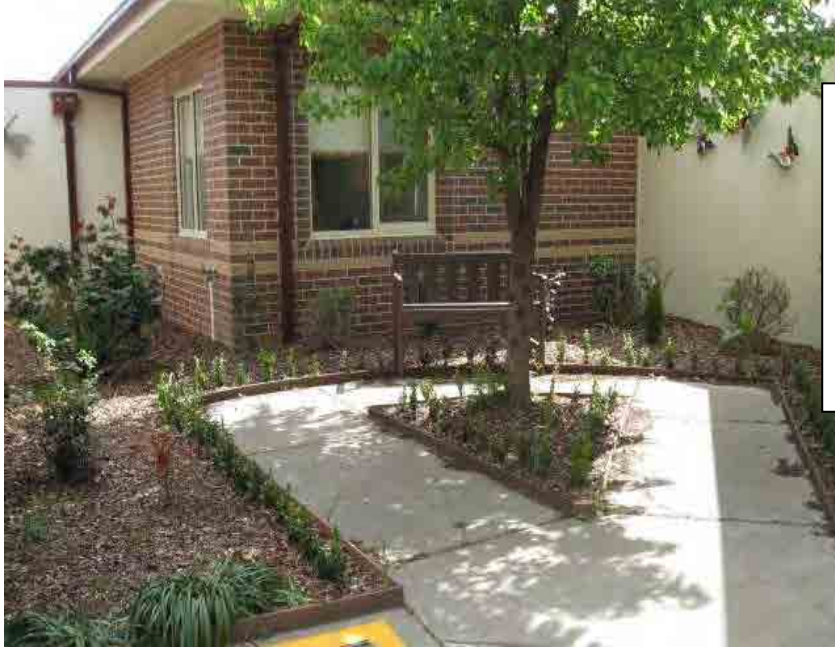
Recommendation 7 – path curves

This pathway is too narrow and sharp for wheeled equipment to turn.

- Note the path is defined by wooden garden edging – this can be a hazard for users and wheeled equipment tipping over the edge.

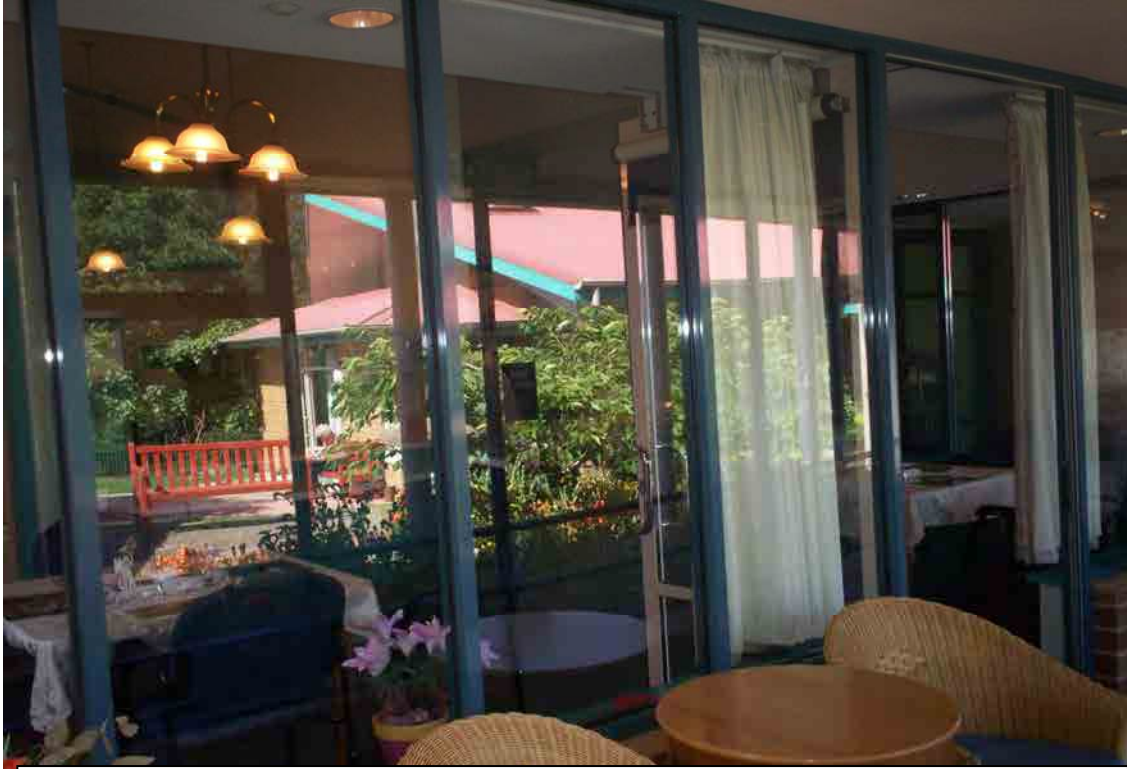
Recommendation 9 – path views

From the garden seat there is a view into other areas inviting participation – firstly the veranda and beyond the veranda to the dining room.

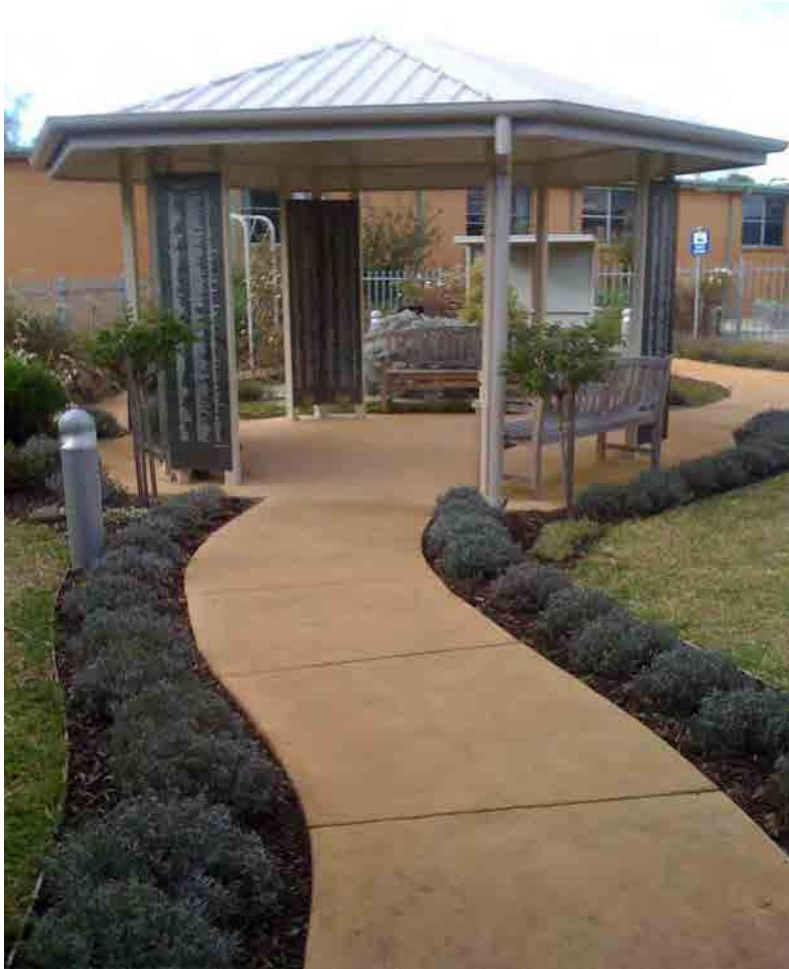
Recommendation 10 – path width

Whilst the gazebo provides a rest point it is difficult to fit a number of wheelchairs/tub chairs in it at the one time.

The pathway gently curves, but cannot fit more than one chair on it at a time; this creates a bottleneck effect in the gazebo with residents waiting for the path to clear.

Lavender plants provide a sensory and decorative definition for the path way; however chairs have toppled off the path as there is a lip between the concrete and the ground.

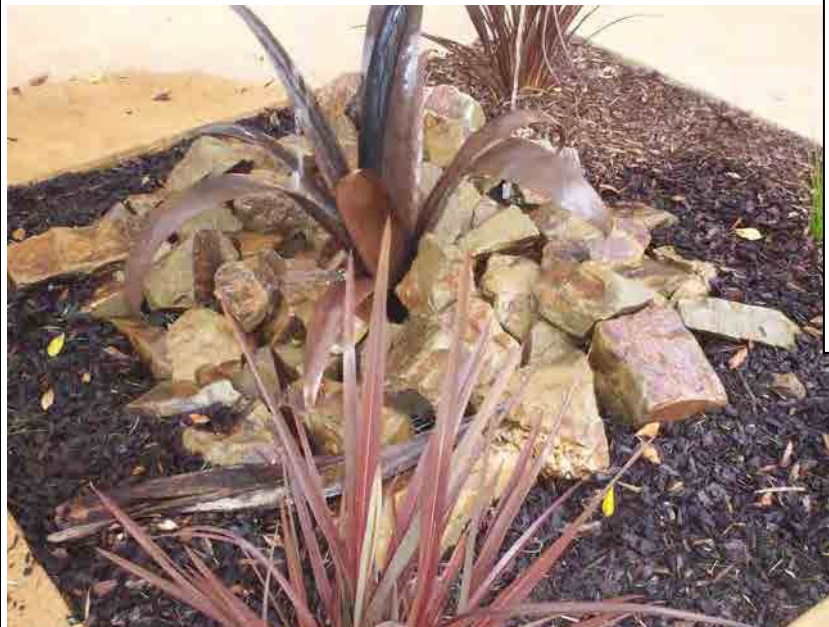
Recommendation 11 – path hazards

This garden has provided a water feature decorated with rocks in a bark bed.

- The concrete lip is higher than the bed and has caused the wheels of chairs to tilt precariously into the rocks.
- The rocks are loose and can be picked up and thrown around.

• (Left) Note the lip of the concrete is higher than the bark bed creating a hazard.

• The free range chickens also tend to spread bark across the path, creating a hazard and requiring constant maintenance.

• (Right) This grate is on a walking path and is hidden by a bush

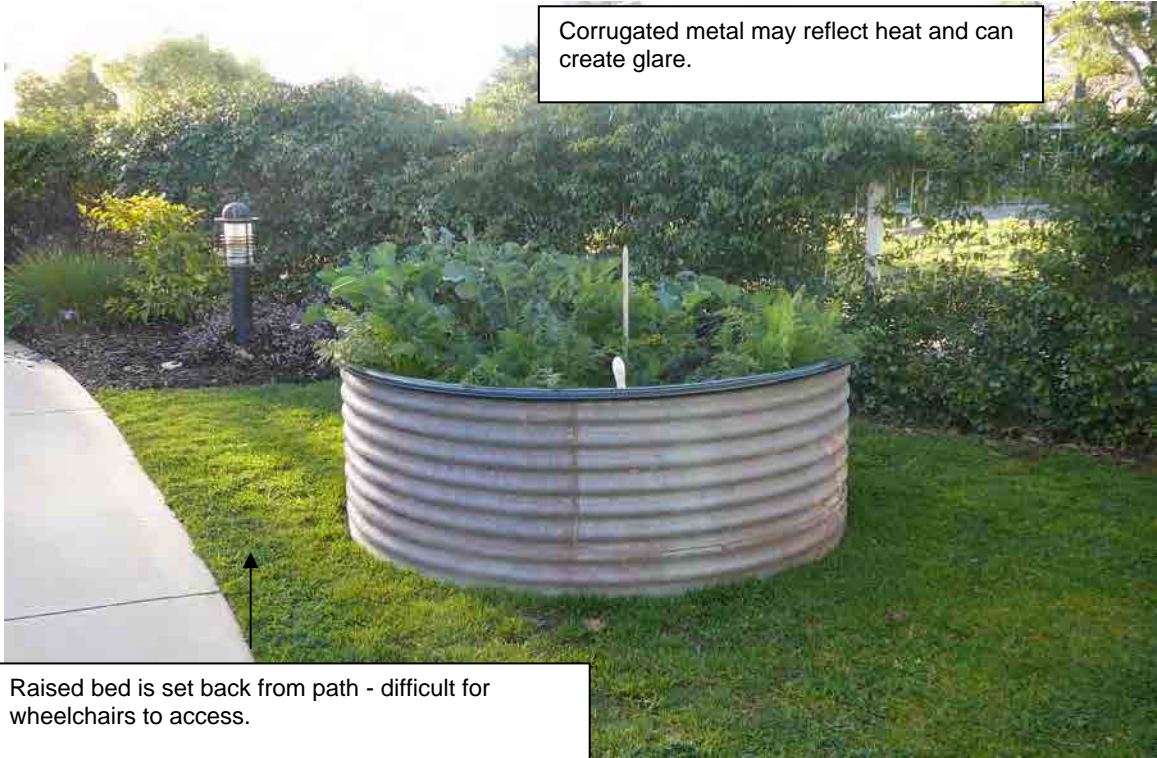
Recommendation 13 – raised garden beds

Corrugated metal may reflect heat and can create glare.

Raised bed is set back from path - difficult for wheelchairs to access.

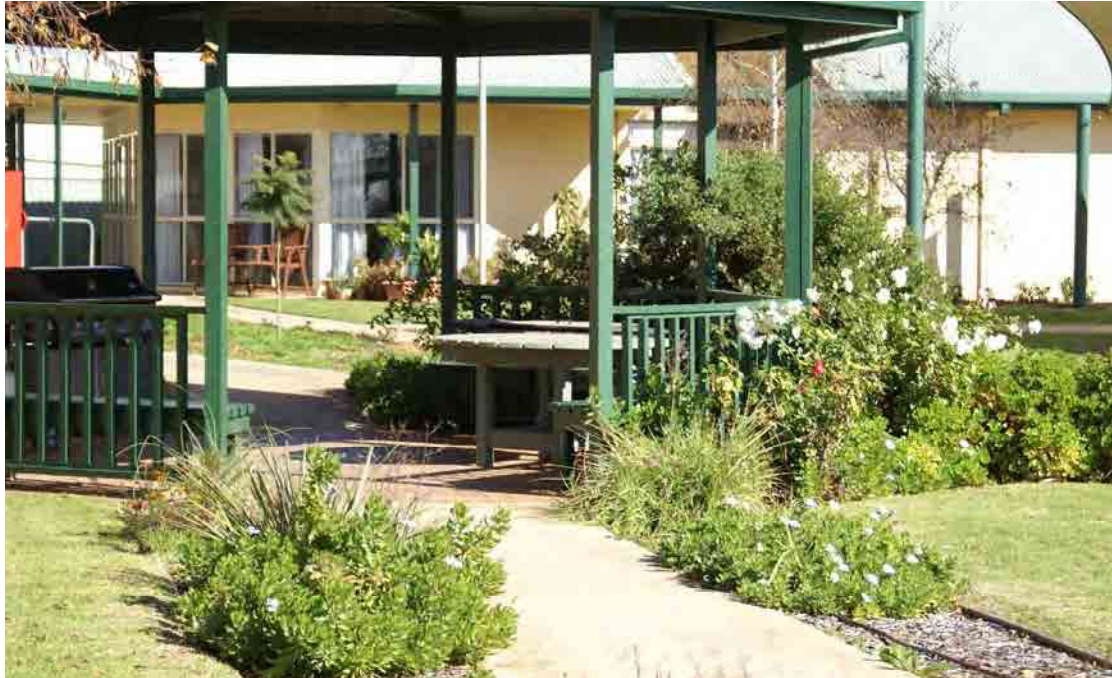
Recommendation 14 – rest areas

This gazebo provides the dual purpose of a shaded rest area and a landmark (place of interest), with a walking path through the centre leading from building to building.

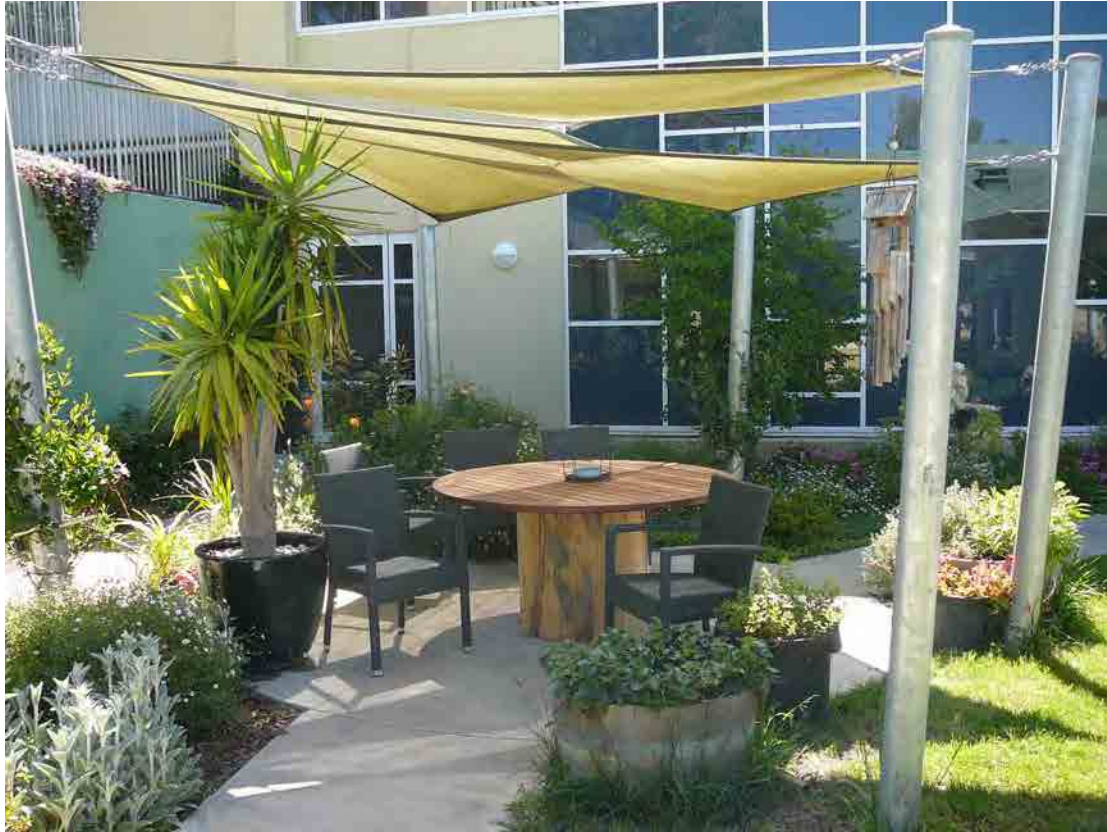
Recommendation 15 – shade

Shade cloth provides shelter in a courtyard.

- Be aware of the glare and heat reflected by the windows and concrete walls during the day.
- Traffic cannot move freely through the centre to follow the path.

The combination of corrugated metal and concrete has created a very hot environment in this internal courtyard, where there is no overhead shade.

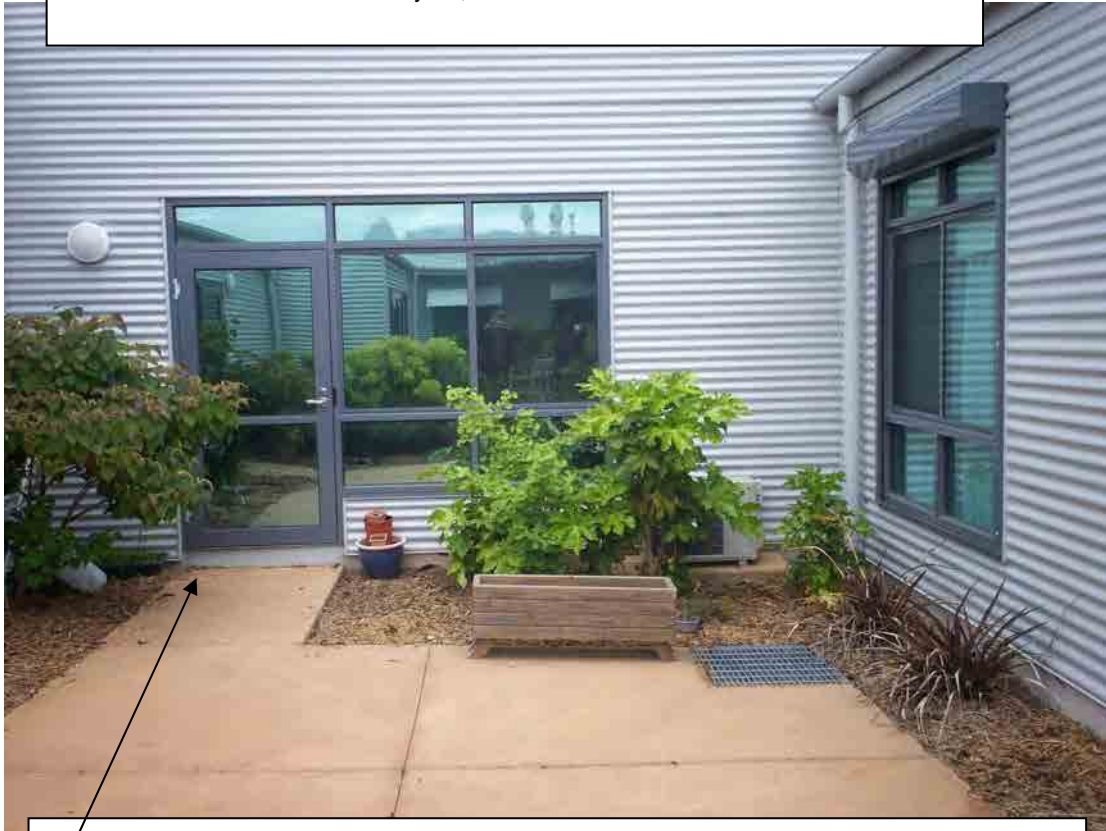
- Note the stepped entry into the courtyard, making it inaccessible for wheeled equipment.
- There is also a lip between the concrete path and the ground, creating a hazard for users.
- The grate is not easily recognisable as a hazard.

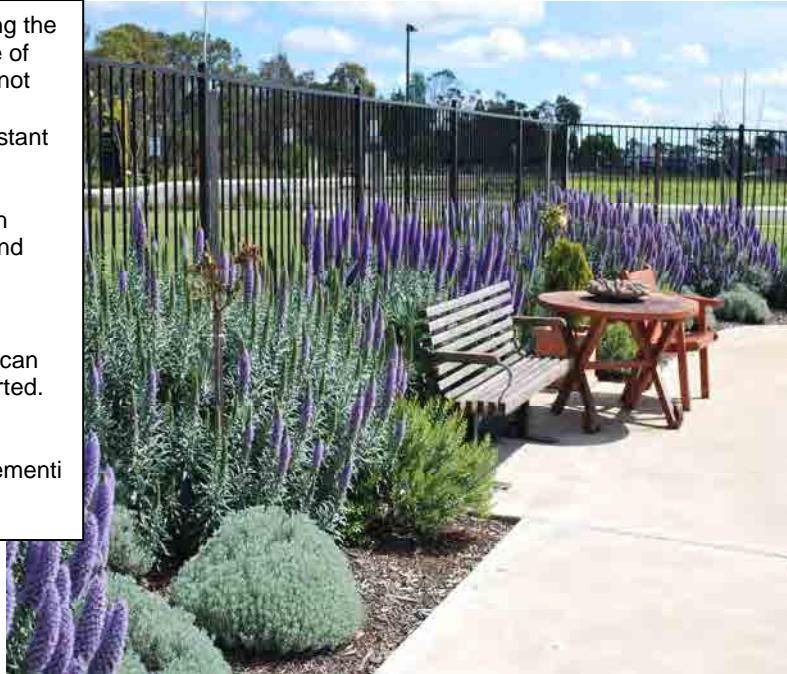
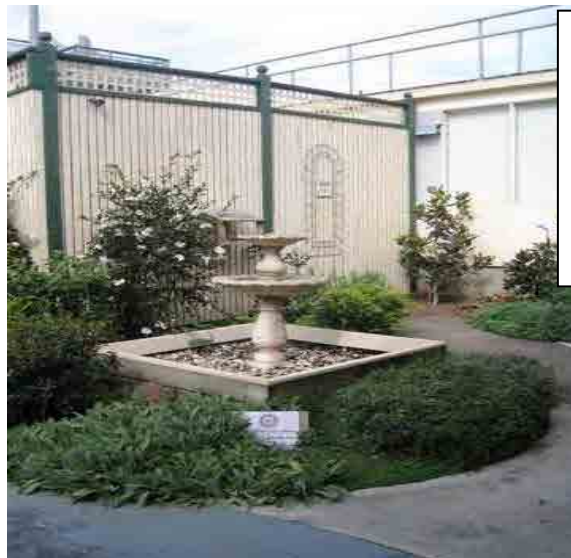
This fence provides an alternative to pool type fencing, and a domestic feel which is found in residential areas.

Planting shrubs and placing ornaments against the fence reduces starkness.

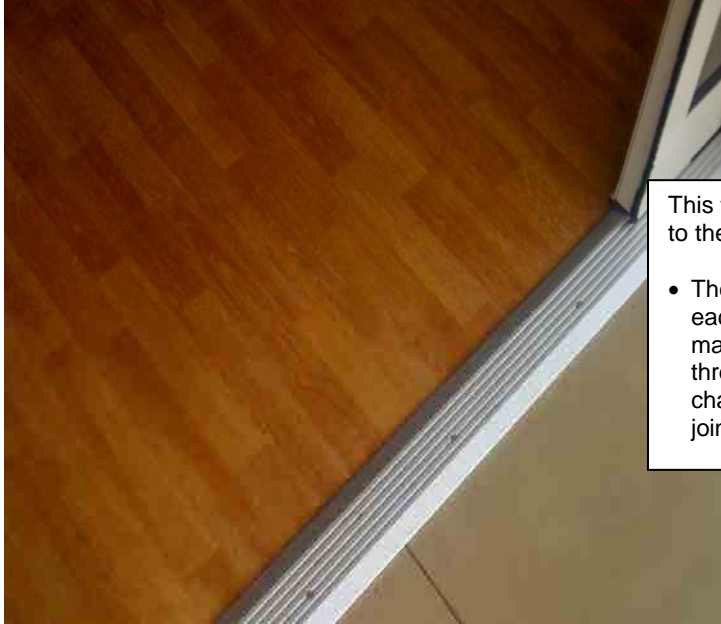
Recommendation 19 – surface changes (refer Rec.51,83,121 photos)

This threshold leads from the dining room to the outside patio.

- The join is raised and stands out against each floor type. It can be argued that it makes residents aware that this is a threshold and to be aware of the change, however a floor level darker joining strip would achieve this purpose.

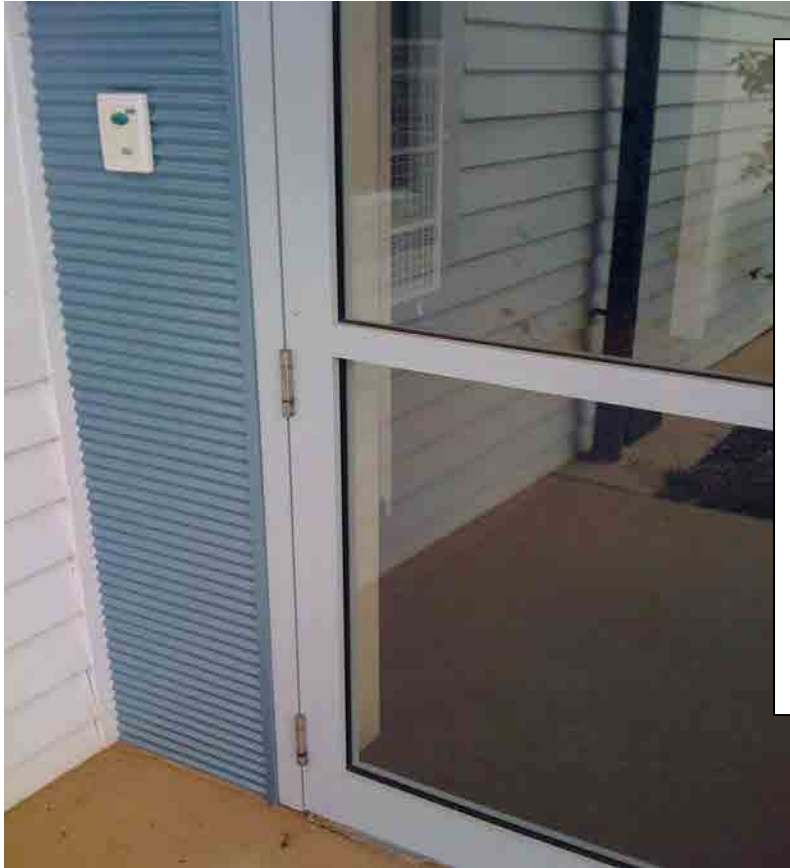
Recommendation 25 – access

This call bell was an afterthought.

Residents were able to wander outside, but once outside, the door locked behind them and they were unable to independently re-enter the building.

- The call bell is easily identifiable and can be reached either sitting or standing.
- However it means a resident has to wait for staff to open the door. It may have been better as a push button entry.
- The door opens on the opposite side to the call bell. For example if a person in a wheelchair pressed this bell then had to move to the other side to open the door, it may have locked again in the interim.

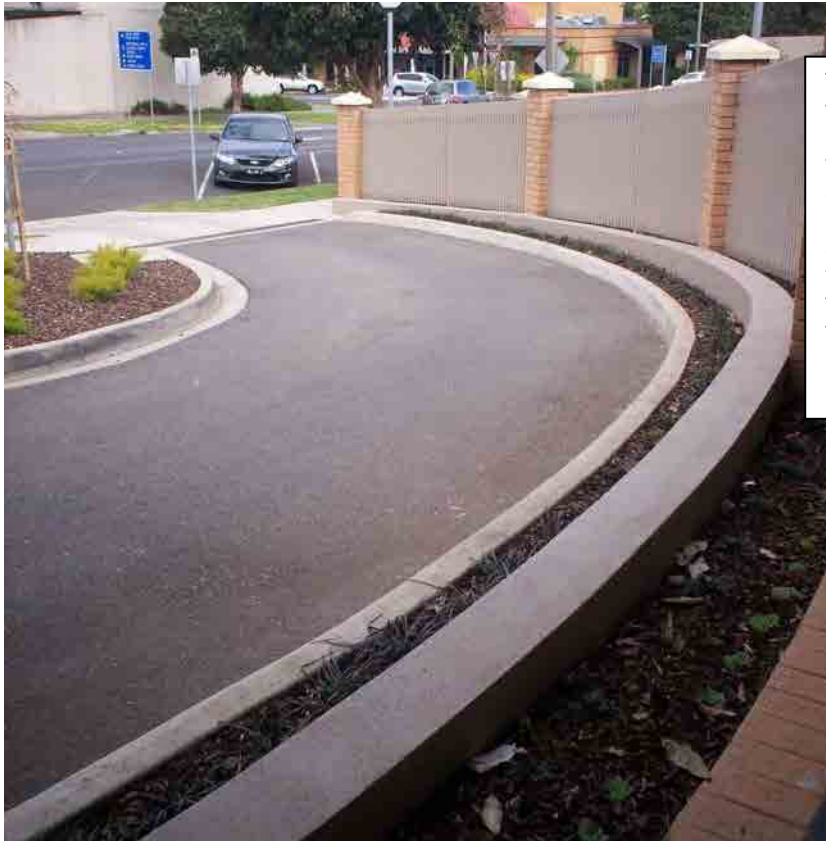
Recommendation 28 – entrance visibility

The driveway to this facility is considered by visitors to be too steep, and does not provide a separate walking path from the street to the front entrance.

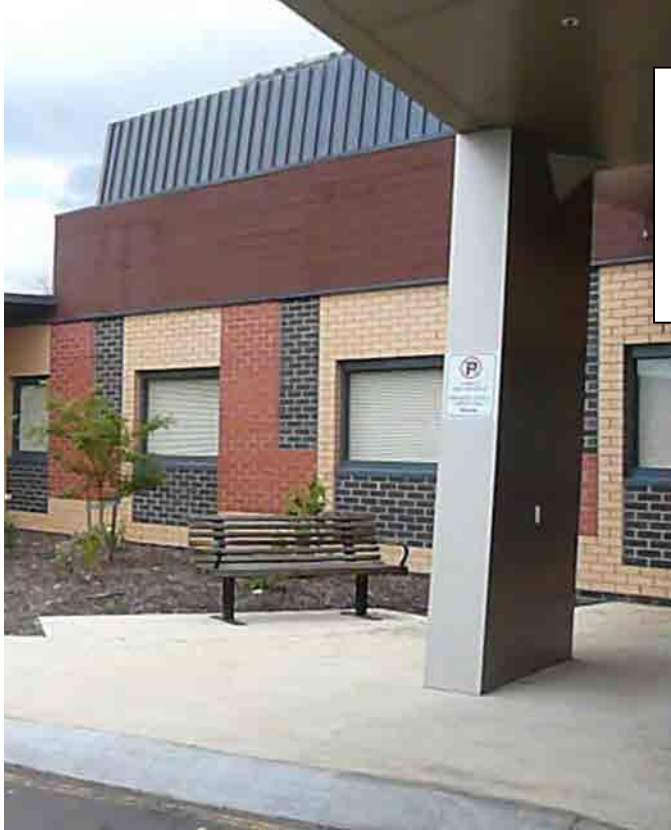
Recommendation 29 – entrance cover

Whilst the main entrance to this RACS provides partial cover, the only external waiting seat is open to the elements. (However, there is internal seating available inside the main door.)

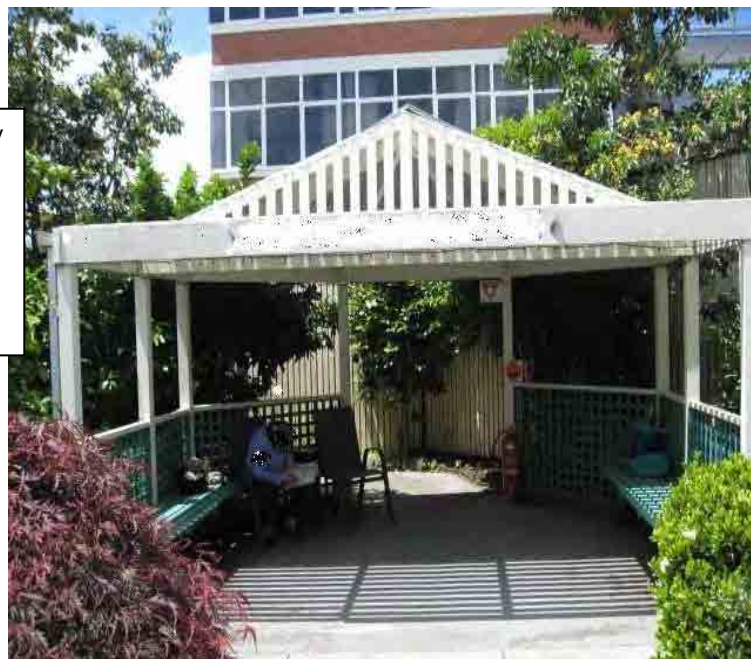
The entrance effectively masks the larger building behind it.

- It provides a shaded rest stop, bus stop and a meeting place.

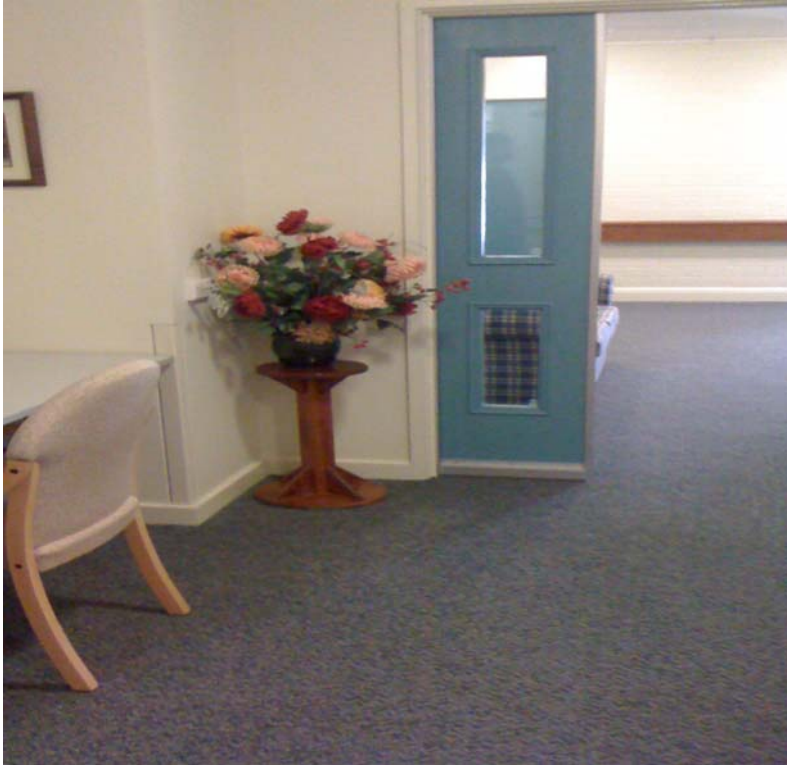
Recommendation 31 – threshold cues (relevant Rec.20)

This facility uses the vase and flowers next to the door to provide a cue for residents to note an entry into another area.

It also provides a landmark for wayfinding.

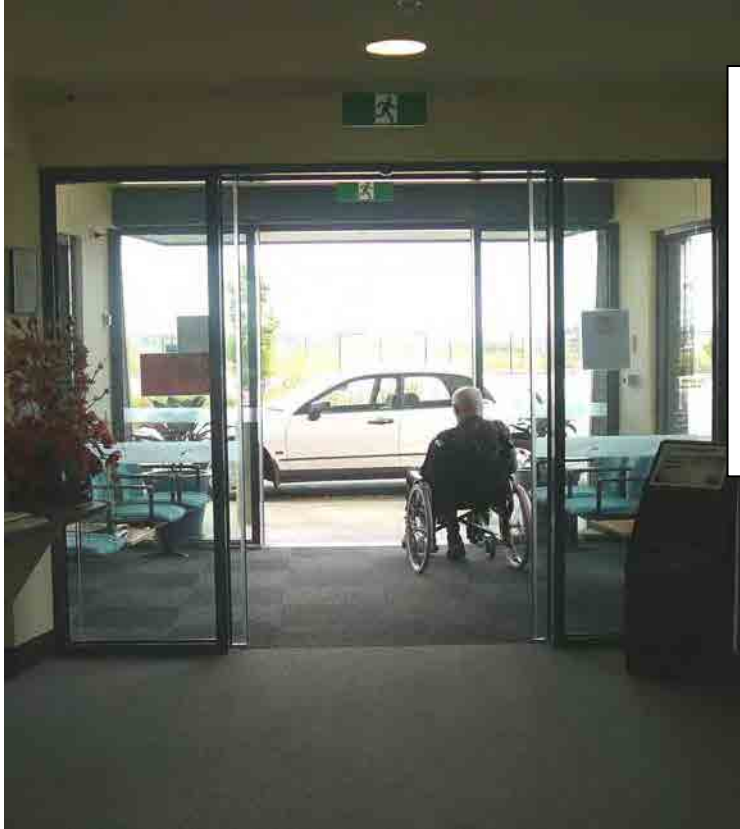
Recommendation 32 – automatic doors

As it is too cold to venture outside to wait, the resident is waiting inside.

- The position of the wheelchair halts the automatic motion of the doors, so both sets remain open.
- This in turn creates an issue with climate control.

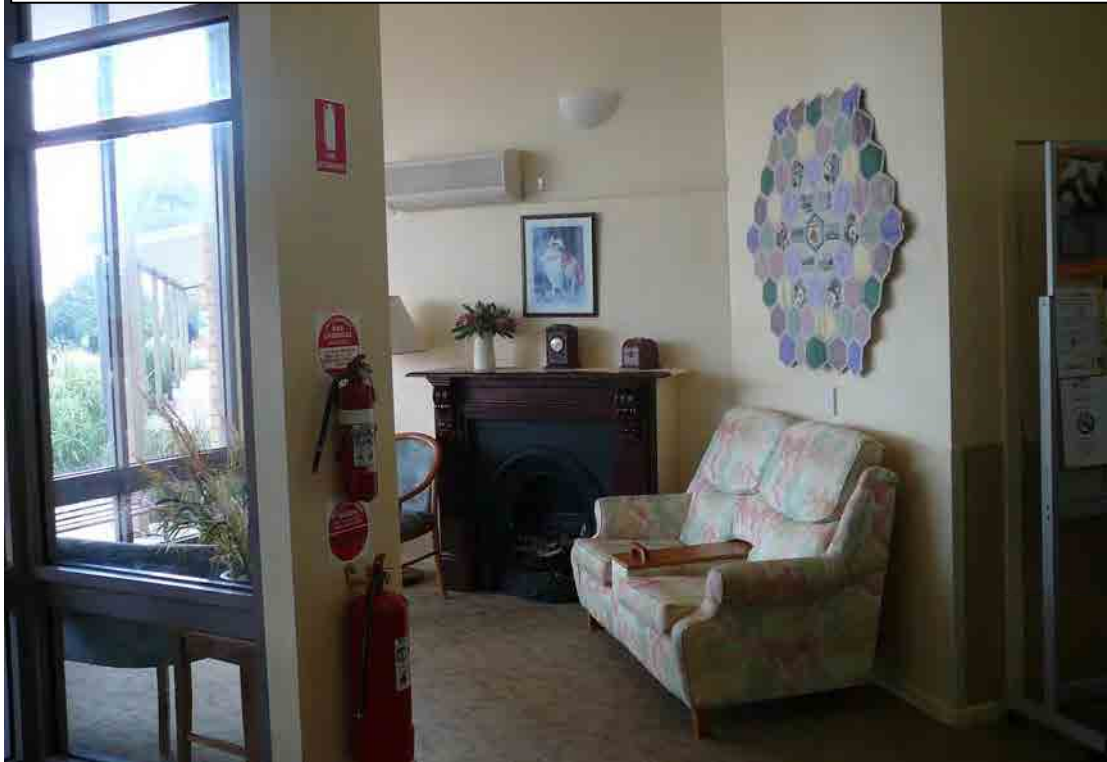
This foyer provides an inviting area to sit, with views to the outside and the main entrance where there is a constant stream of activity.

- The domestic feel is marred in part by the fire equipment located next to the entry.

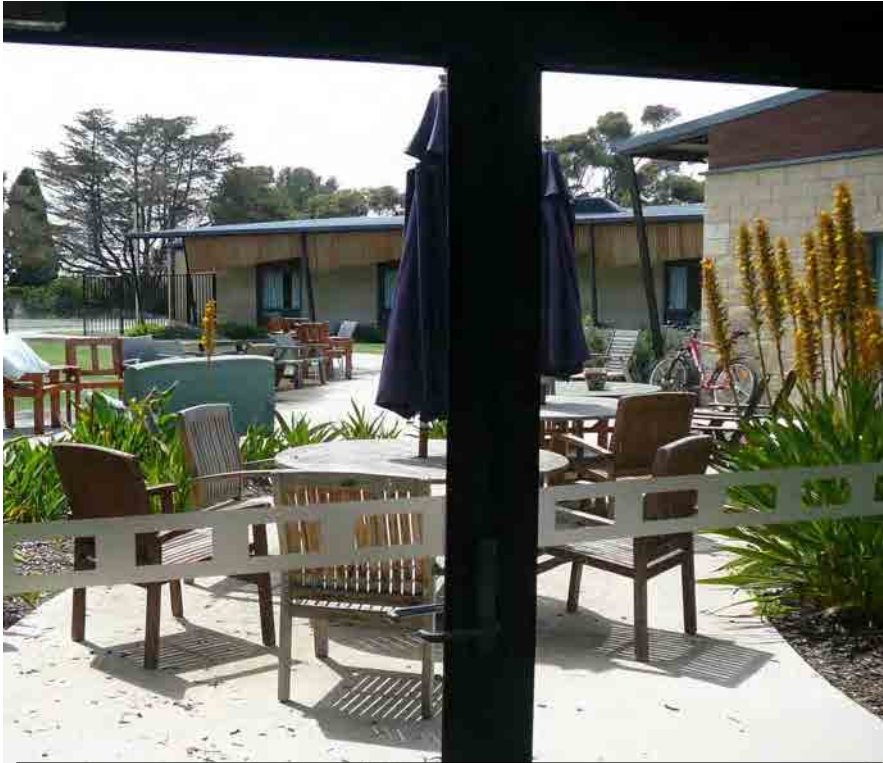
Recommendation 41 – glass doors (relevant Rec.72)

(Above) The doors have a pathway leading into a garden area with tables and chairs. Unfortunately this area cannot be accessed so the doors remain locked.

- Residents may be attracted to the pleasant view and become frustrated when they are unable to access it, so it may be better to camouflage this exit.

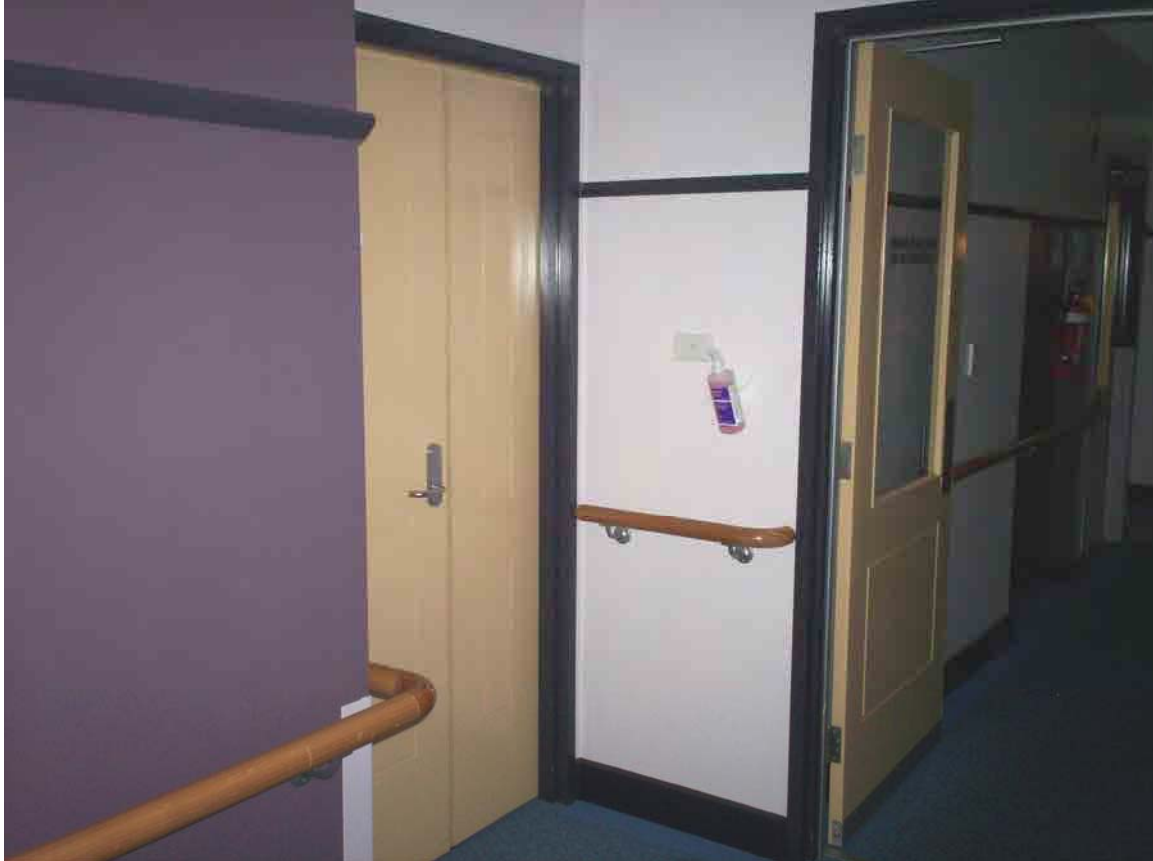
Recommendation 42 – door contrast (refer Rec.112 photo)

- The door stands out against the architrave, wall and floor and is easily distinguishable.
- The handrails stand out against the background and lead the user to the bedroom door.

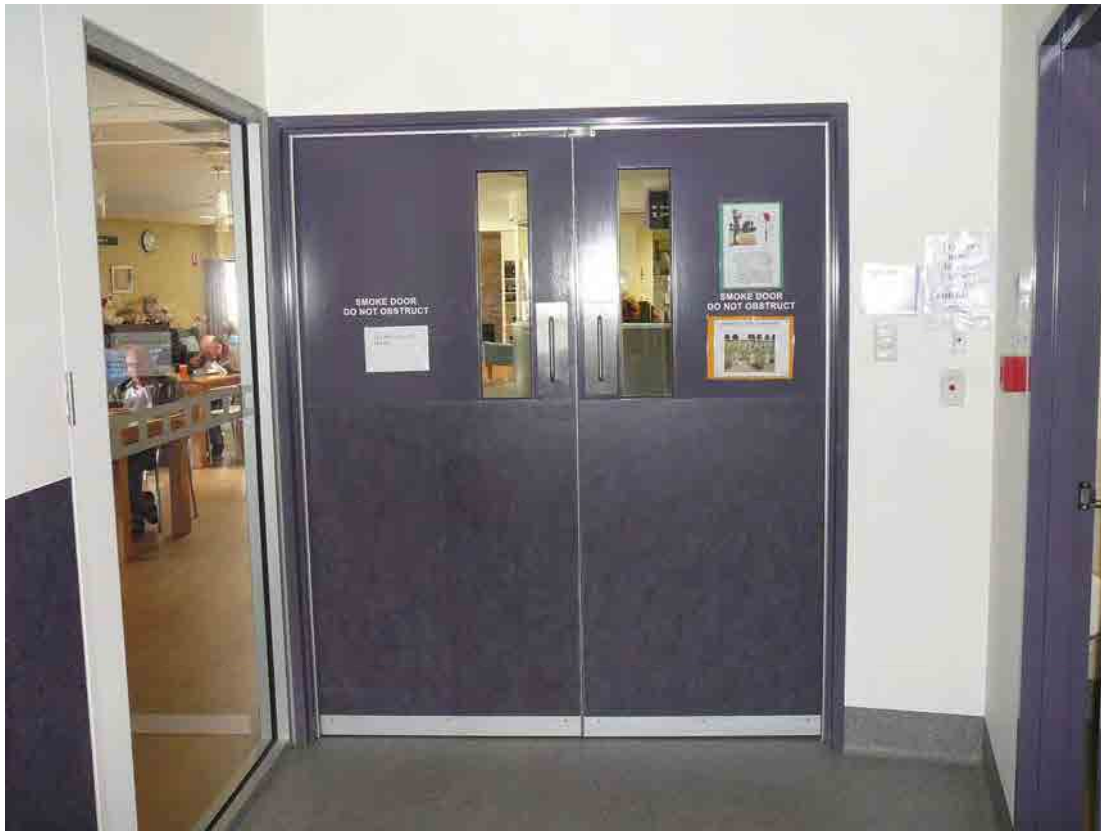
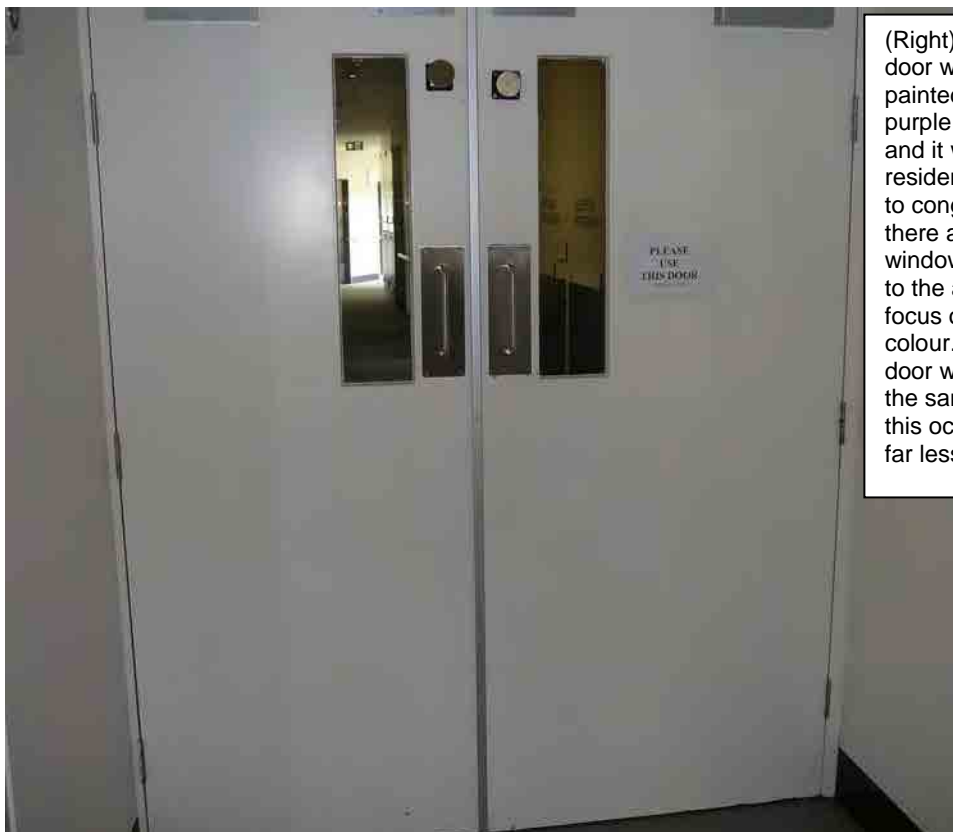
Recommendation 43 – door camouflage (refer Rec.75 photo)

(Right) This exit door was originally painted a darker purple (as above) and it was found residents tended to congregate there at the windows – drawn to the area by the focus of dark colour. When the door was painted the same colour, this occurred to a far lesser extent.

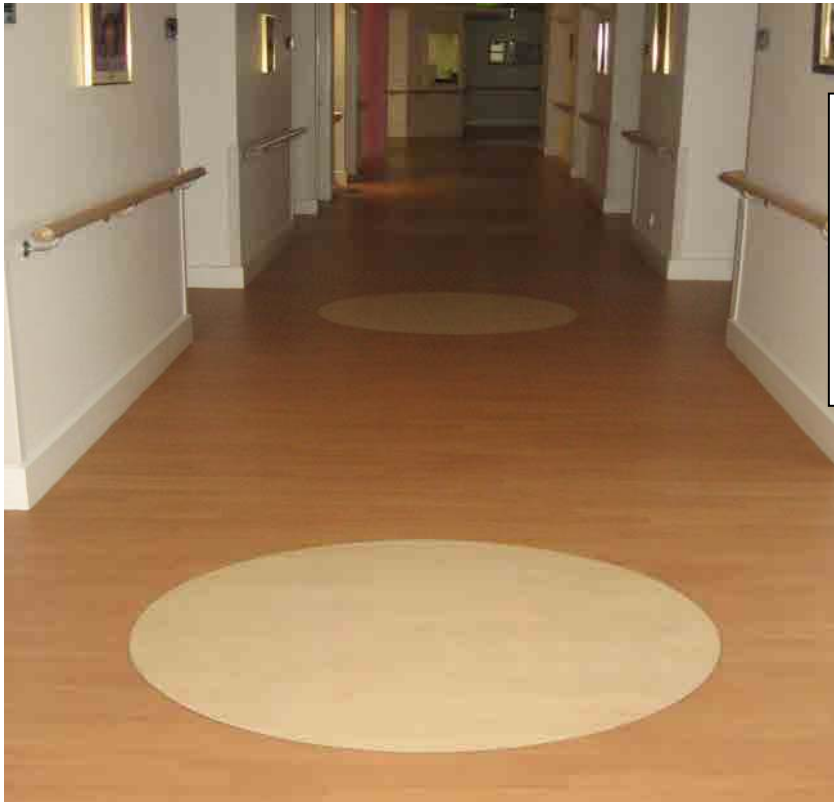
Recommendation 50 – floor colours (refer Rec.82 photo)

New residents got down on their hands and knees and crawled around the sides to avoid walking across these circles, which they perceived as holes or piles of sand.

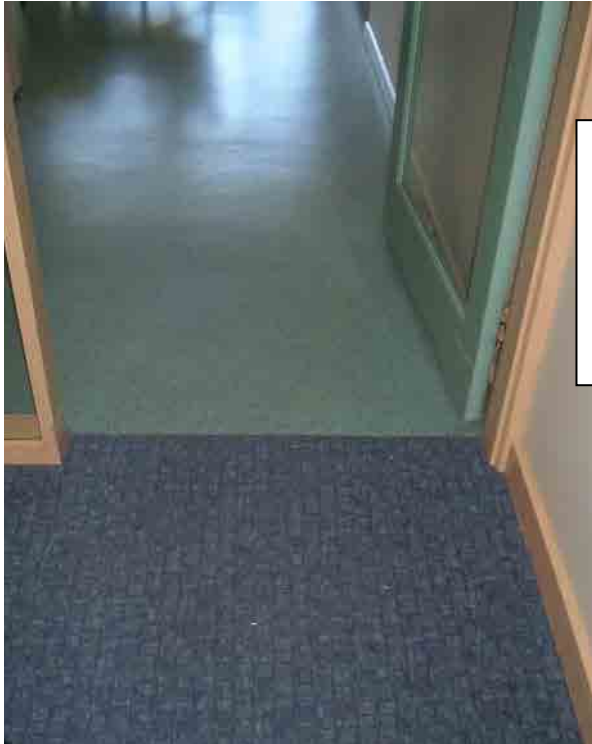
Recommendation 51 – floor surface changes (refer Rec.19, 83, 120 photos)

This change in floor covering is at an expected area - a doorway.
As a further cue the door is painted a different colour from the architraves.

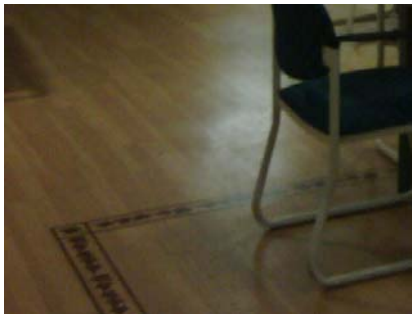
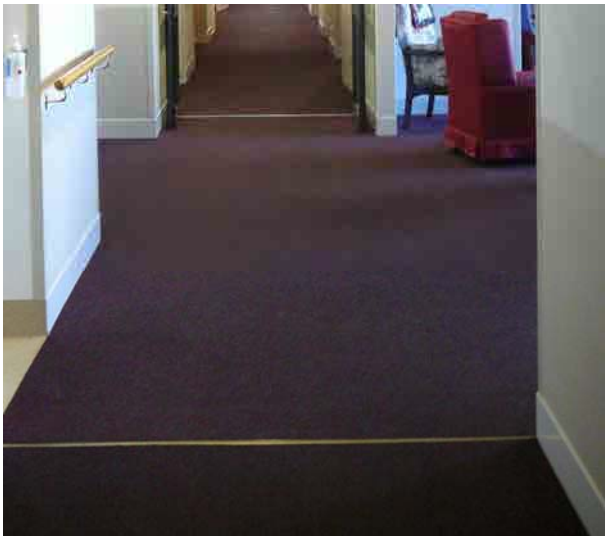
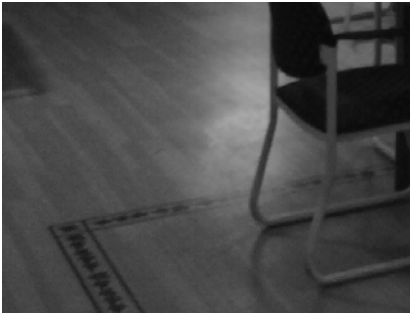
Recommendation 52 – joining strips (refer Rec.84 photos)

These floors have examples of patterns and strips which may give the illusion of steps.

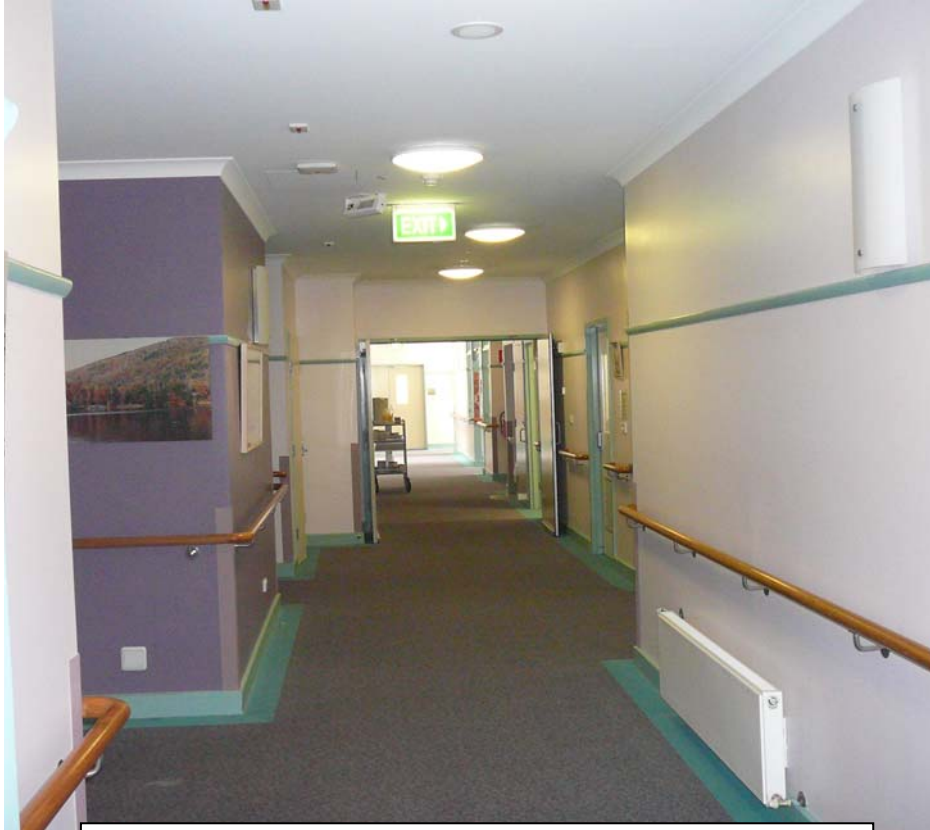
Recommendation 53 – walls contrast (relevant Rec.85,123)

- The walls contrast with the architraves, handrails and floor.
- The darker feature wall reduces the impact of the hallway and acts as a cue for residents to locate their rooms.

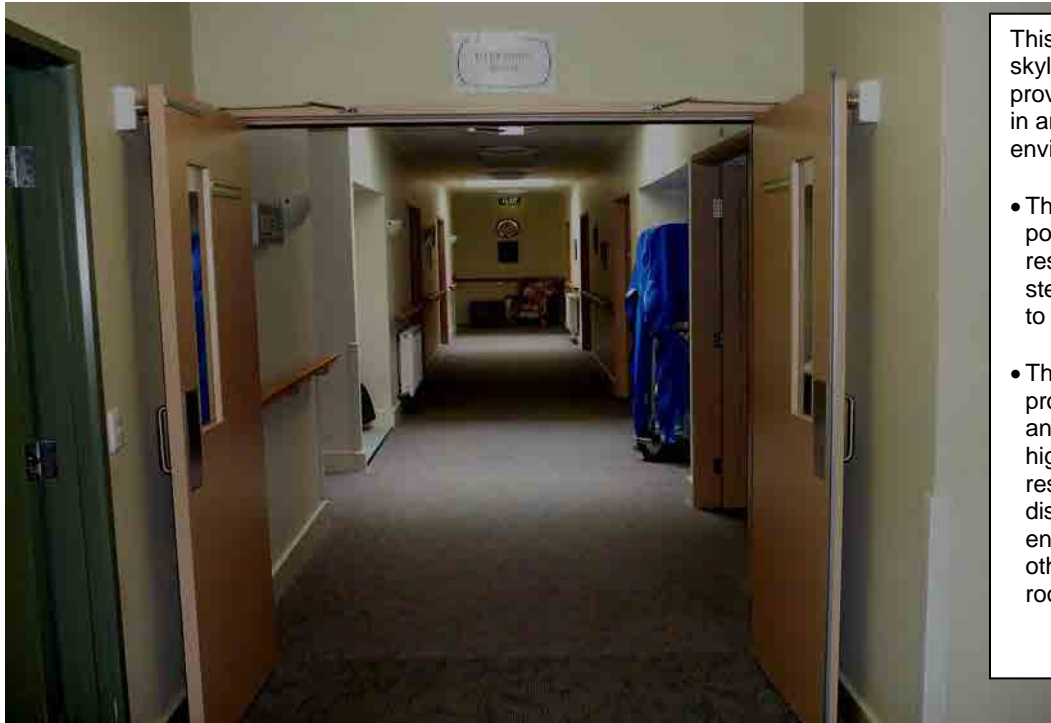
Recommendation 54 – lighting (relevant Rec.86,124)

This hallway has 2 skylights designed to provide natural light in an otherwise dark environment.

- They have created pools of light where residents are stepping from light to darkness to light.
- Their positions also provide a focus and inadvertently highlight areas that residents may be discouraged from entering, such as other residents rooms.

This hallway leads to a dead end for residents.

- The skylight is positioned between the resident rooms. It draws the resident's attention to it.
- It also creates glare.
- Perhaps painting the dead end cupboard a lighter colour to match the walls will discourage residents from walking to the dead end, and also serve to lighten the hallway.

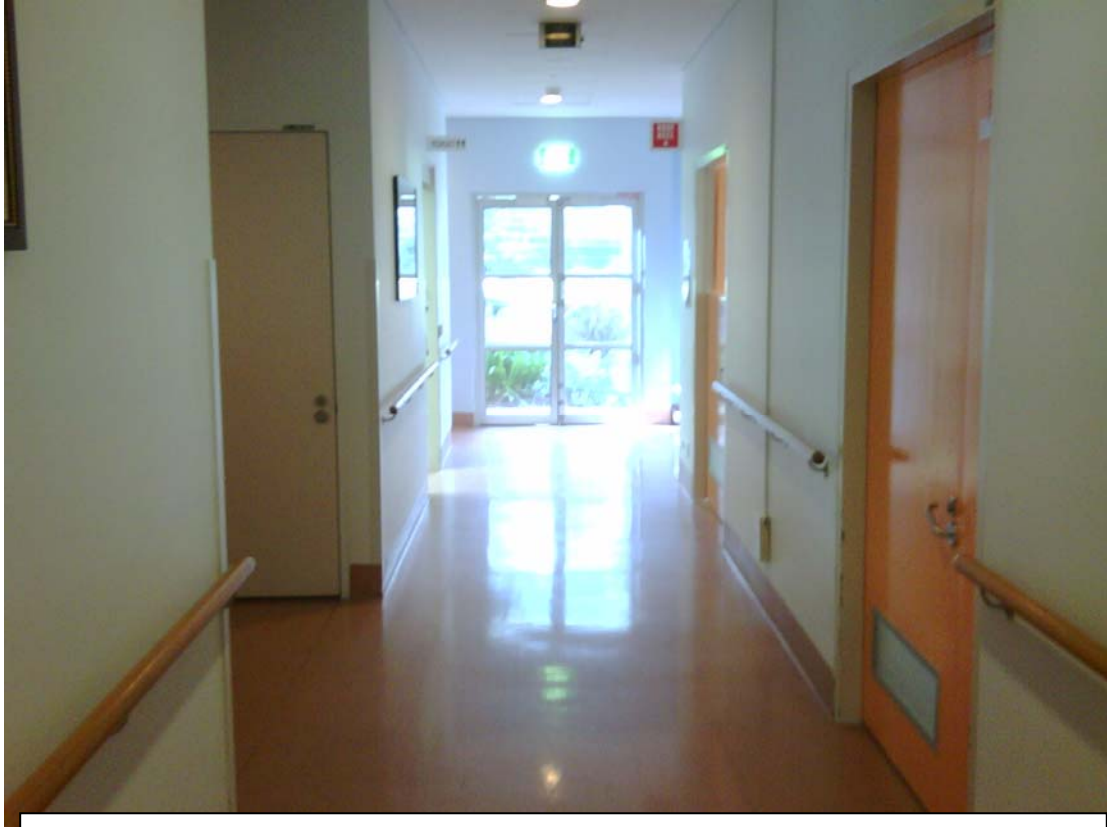
Recommendation 55 – glare (refer Rec.87,125 photos)

Be aware of the glare reflected off shiny, buffed floor surfaces. Residents can perceive this as a pool of water to be walked around – or waded through. (Brawley)

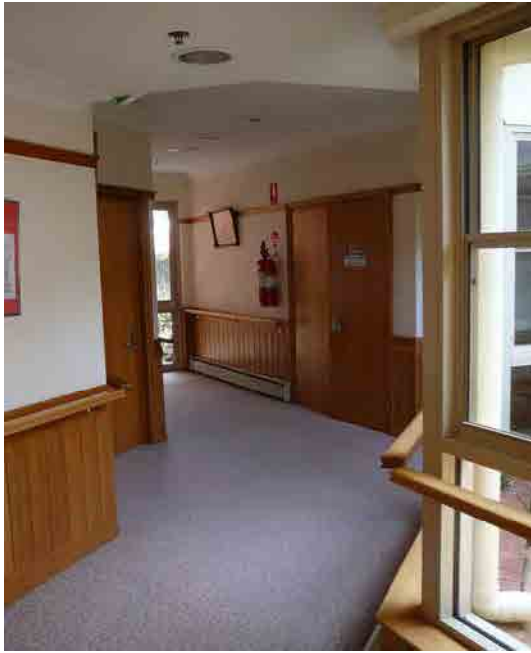
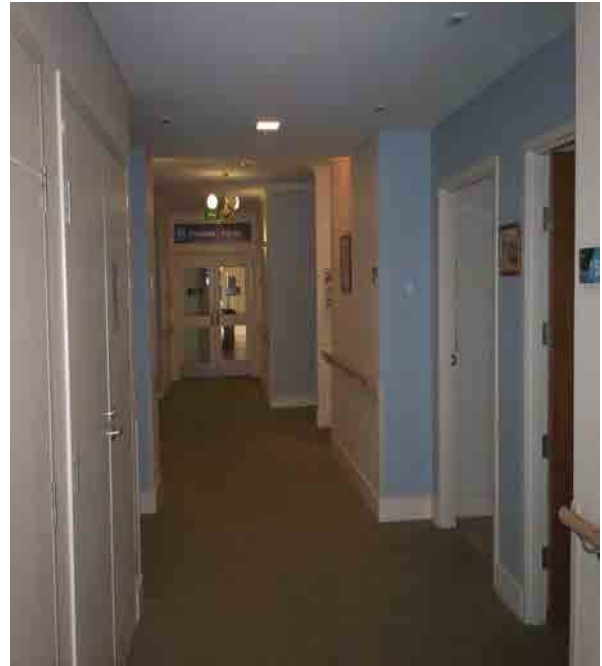
(Above) Note the handrail blends in with the panelling and may be difficult to see.

- The doors access is a staff only area and may have been better camouflaged i.e wood panelling on the bottom and cream on the top to blend in with the wall.
