Residential aged care services built environment audit tool

Online version 1.2: Part 5. Photo gallery

5. Photo gallery

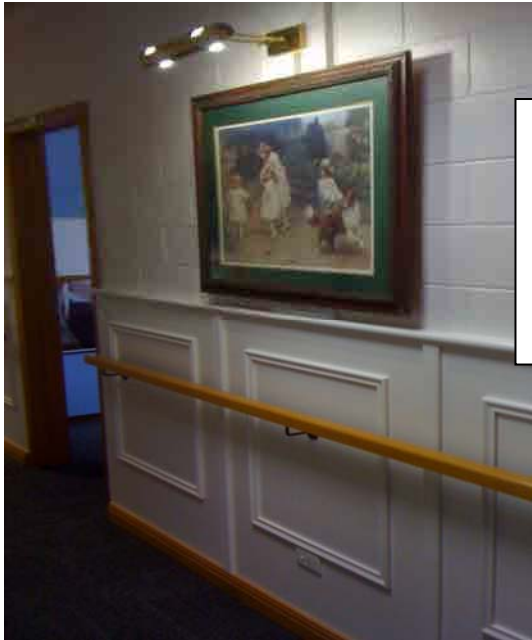
Recommendation 58 – artwork (relevant Rec.89)

- The artwork is situated along a hallway.
- The painting has a dark frame against a light background.
- The wall light focuses on the painting drawing attention to it.

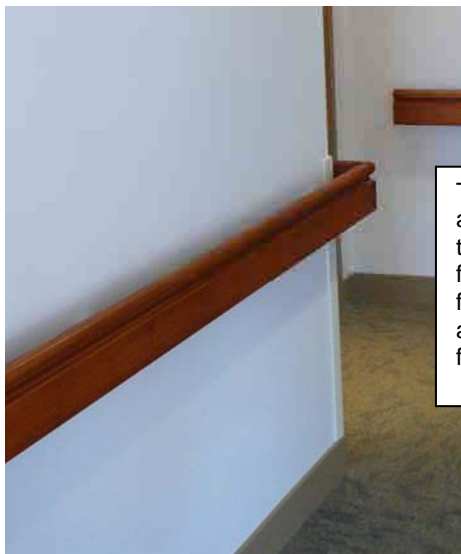
Recommendation 67 – handrails

The handrail stands out against the wall. It is round at the top for ease of grip and filled in at the bottom: suitable for use in both generic and aged persons mental health facilities.

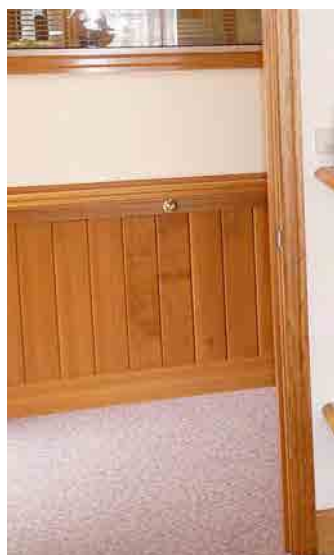
The panelling and handrail create a warm timber feel.

- However, this handrail appears camouflaged by the wall panelling, making it difficult for the user to see.

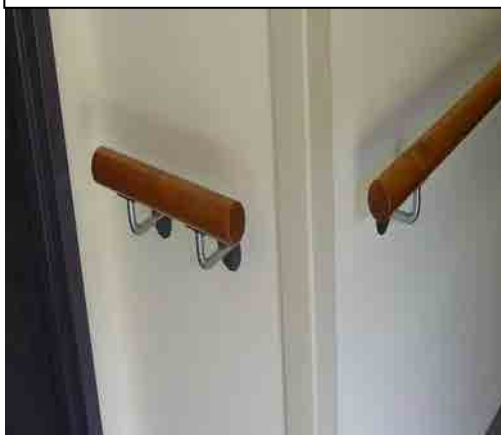
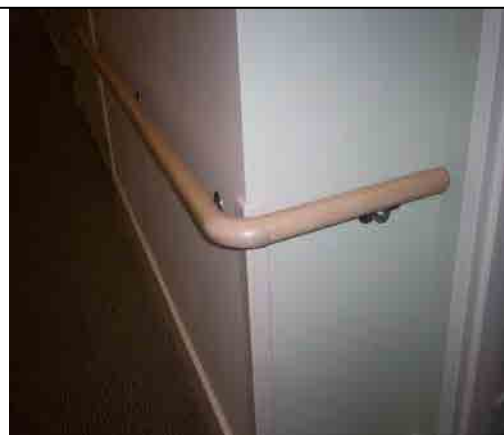
For wayfinding and support a handrail should be continuous around corners. However it can be argued handrails leading into resident rooms may encourage unwanted visitors

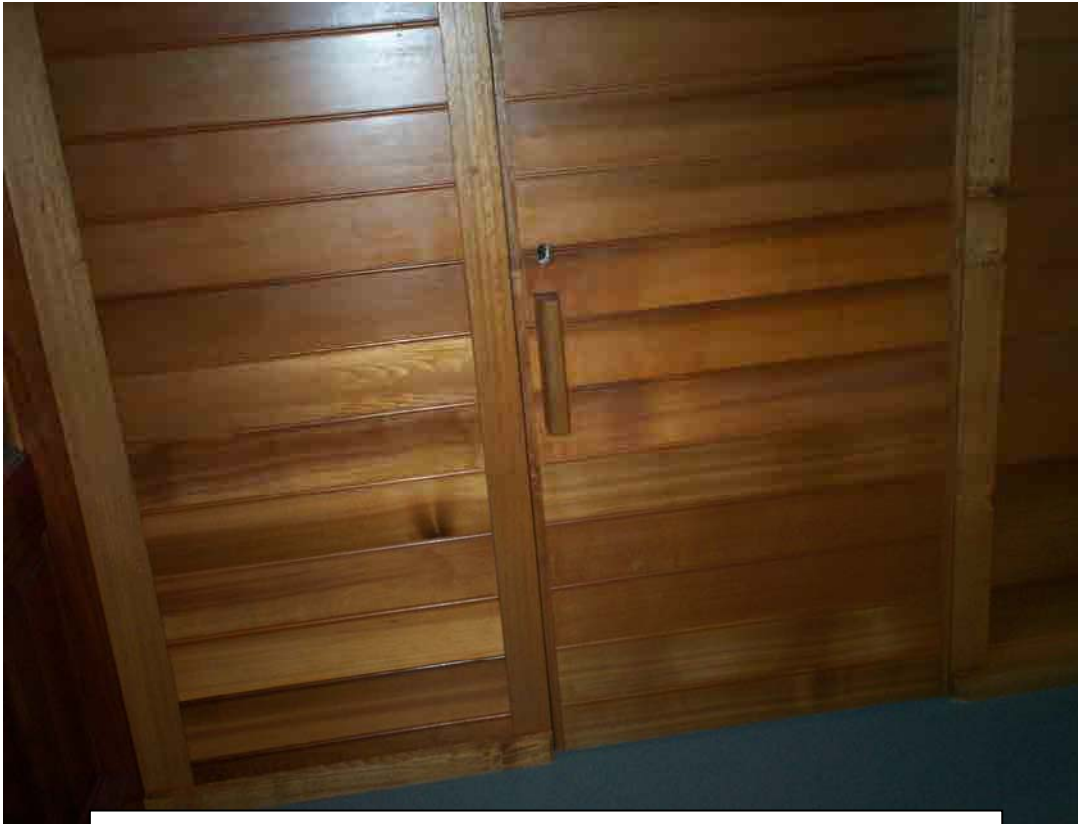
Recommendation 75 – camouflage (refer Rec.43 photo)

This door leads into a staff area near a lounge. The doors are disguised the same as the walls with only the keyhole and handle showing it is a door.

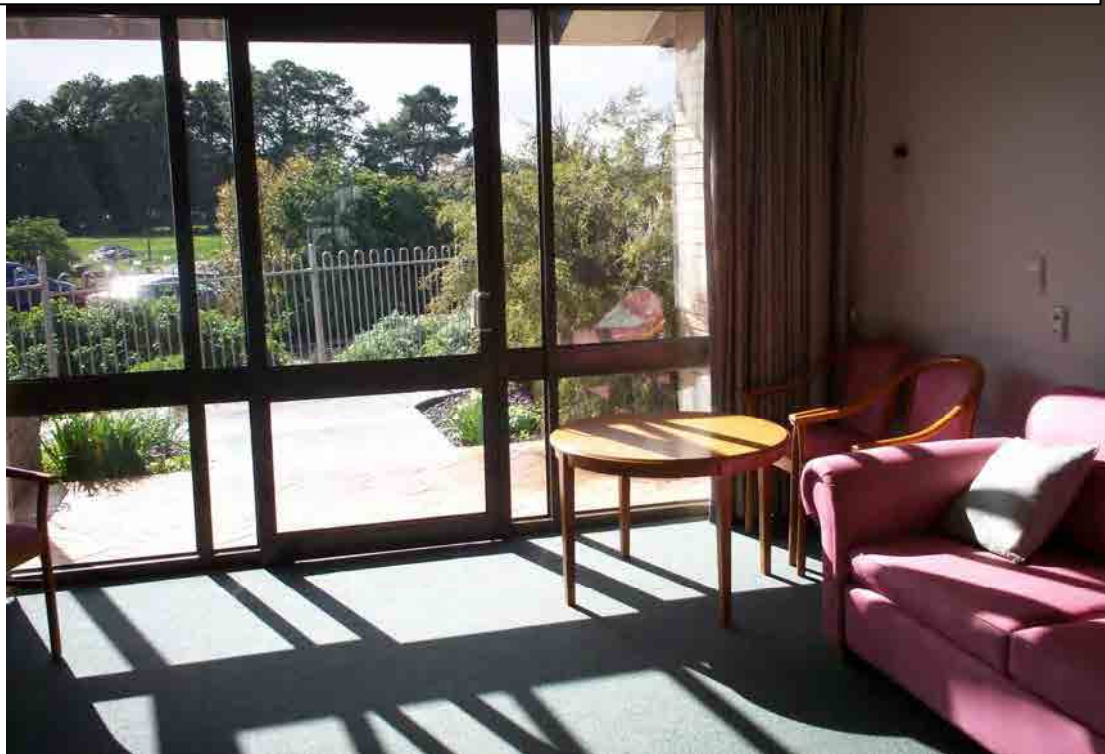
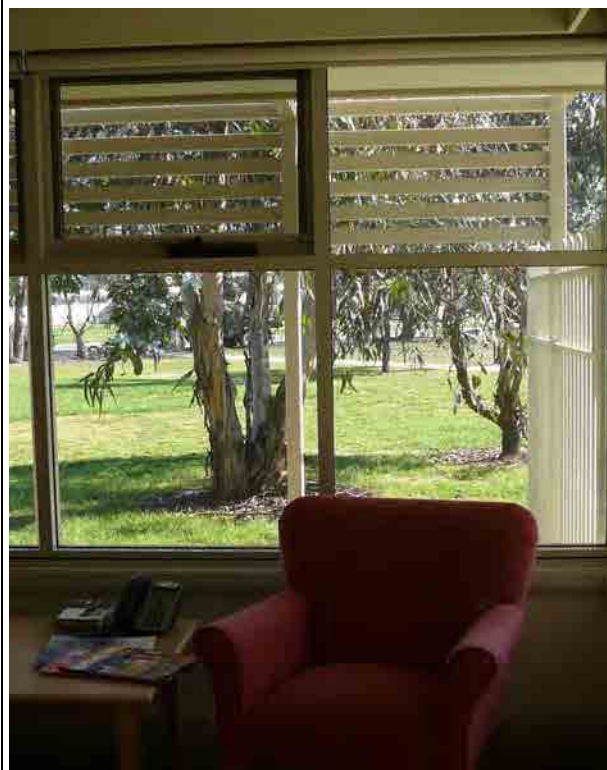
Recommendation 80 – floor matte finish (relevant Rec.48,118, 161)

Sunlight at certain times of the day can cause striped shadows on the floor, giving the appearance of lines, which can be confusing to vision impaired residents.

External slats designed to provide shelter and also allow ventilation, have created shadows which may appear as steps to vision impaired residents.

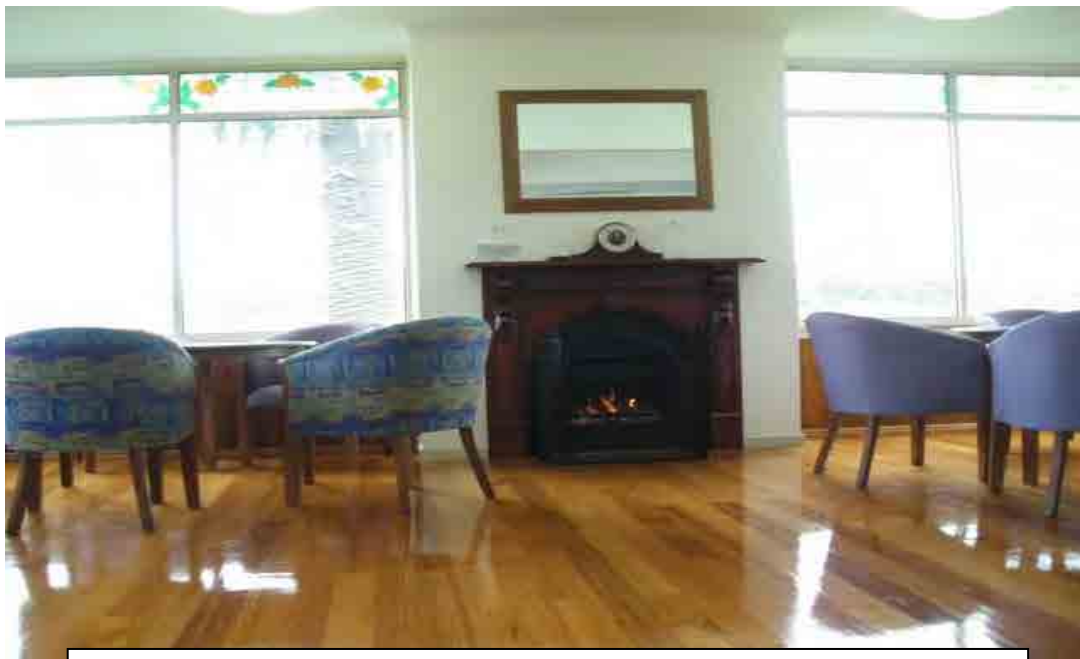
A dining room with a view:

- Notice the glare from the windows
- Notice the glare on the floor.

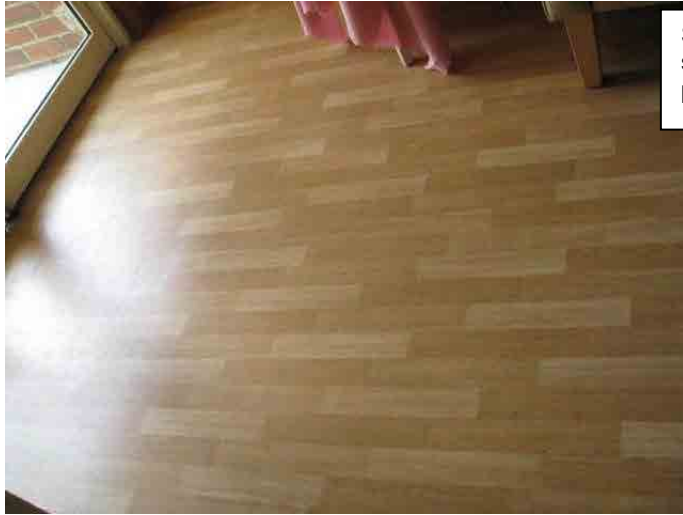
Recommendation 82 – floor colours (refer Rec.50 photo)

Staff reported some residents stepping around the light and dark patches of this floor.

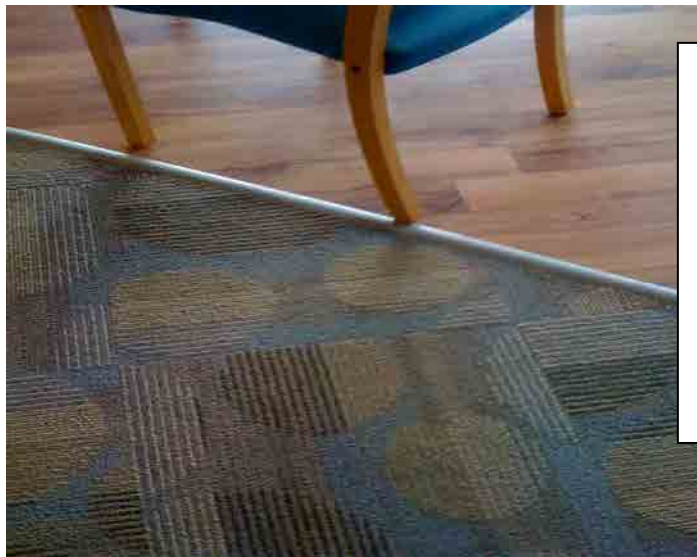
Recommendation 84 – joining strips (refer Rec.52 photos)

The dining and lounge areas at this facility are combined in one room, and the distinction between each is made by the floor surfaces.

- Staff report that residents stop at this strip and need to be guided over it.
- The strip itself is a tripping hazard, as it is not flush with the floor.
- The patterned carpet also creates areas of light and shade.

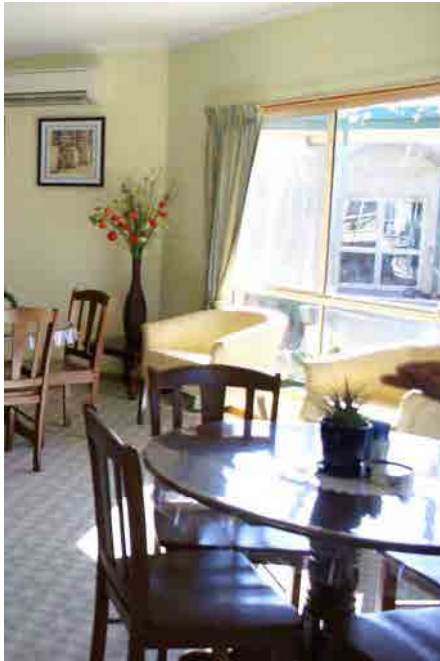
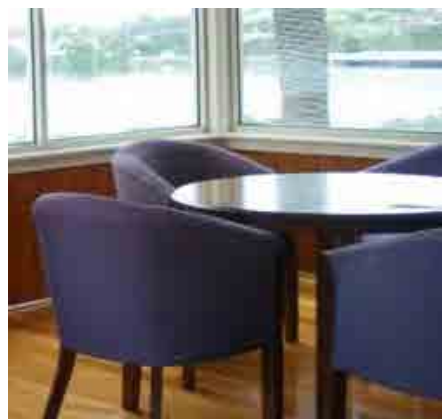
Examples of table glare, easily overcome by the use of tablecloths.

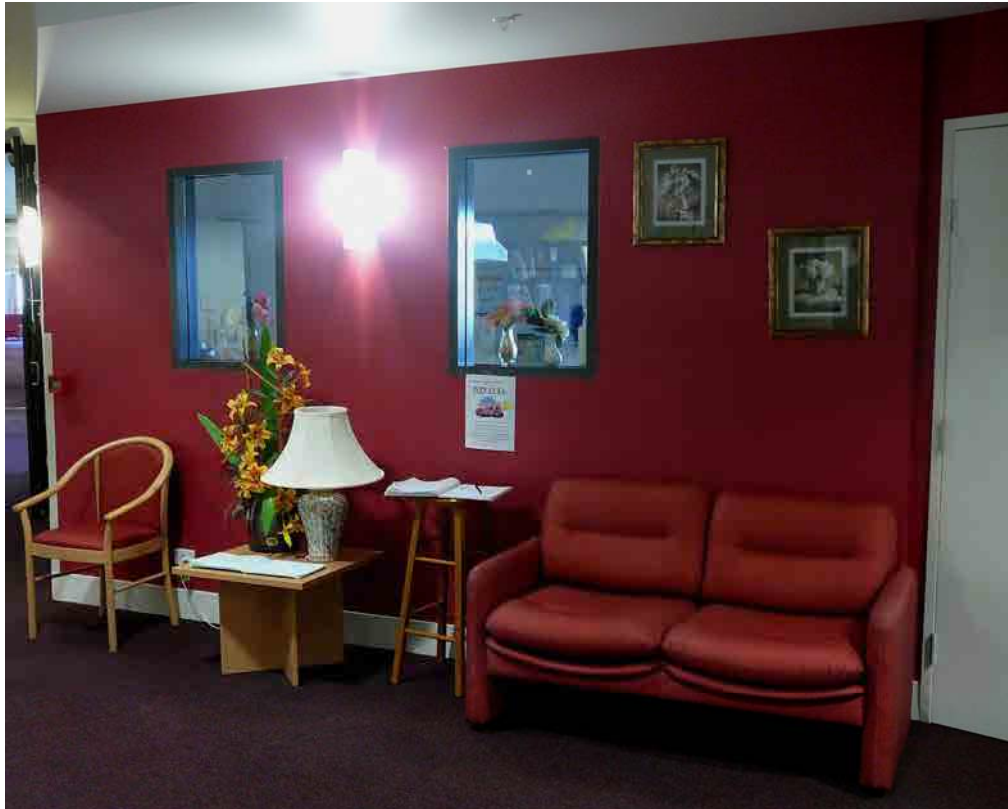
Recommendation 96 – furniture comfortable (relevant Rec.64, 144)

- Red furniture blends into the red wall and can become a blur for vision impaired residents and visitors.

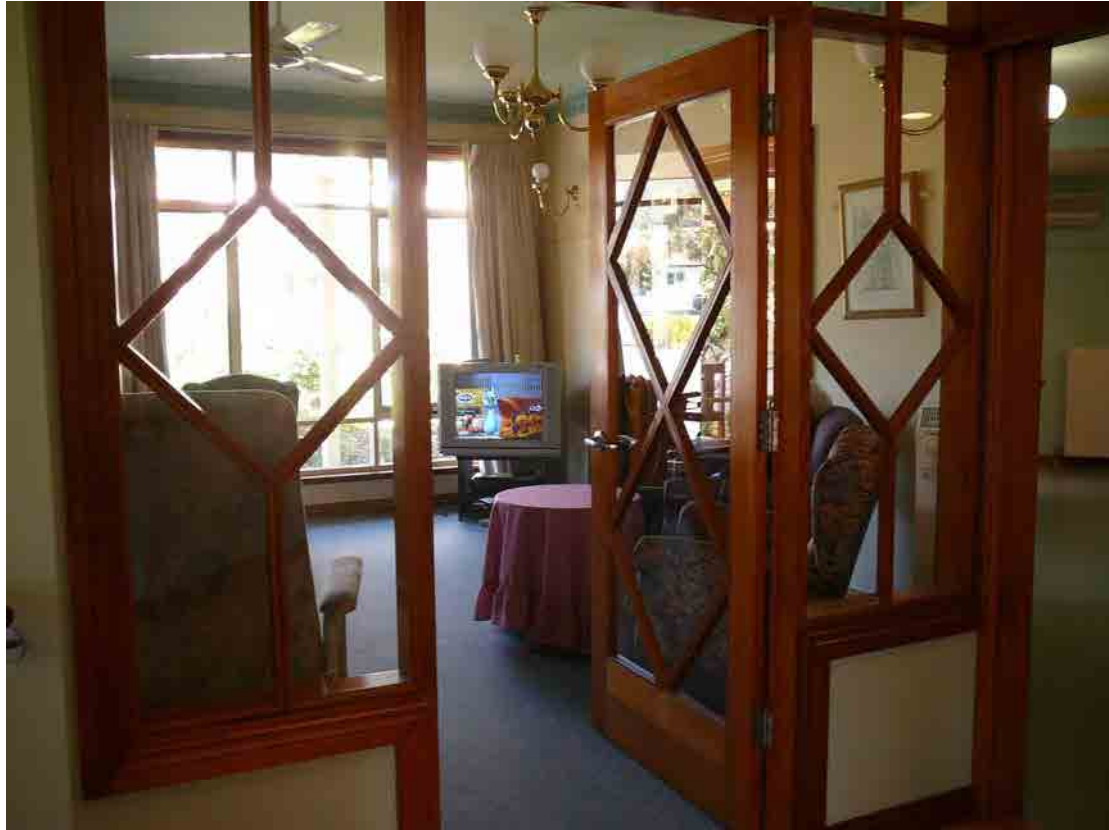
Recommendation 100 – social interaction

A small sitting room located off the main hallway. It can be easily seen and accessed for watching television, or alternatively used for visitors or as a quiet retreat.

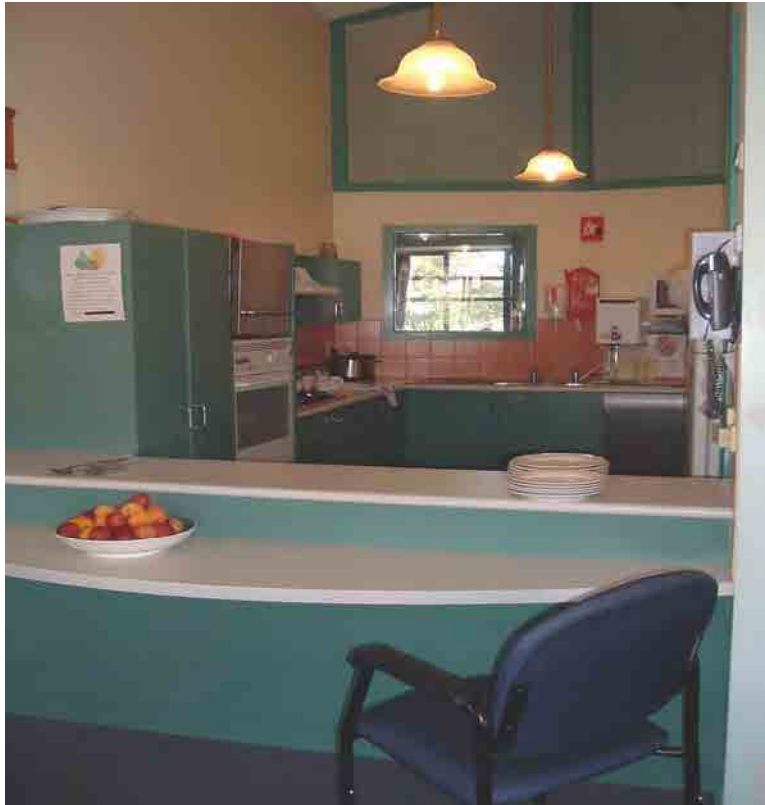
Recommendation 104 – kitchenette

This kitchen opens into the dining room and food is available over the bench top.

- Colour contrasting highlights features for different uses.
- There is under bench seating and wheelchair access for watching and participating in activities.

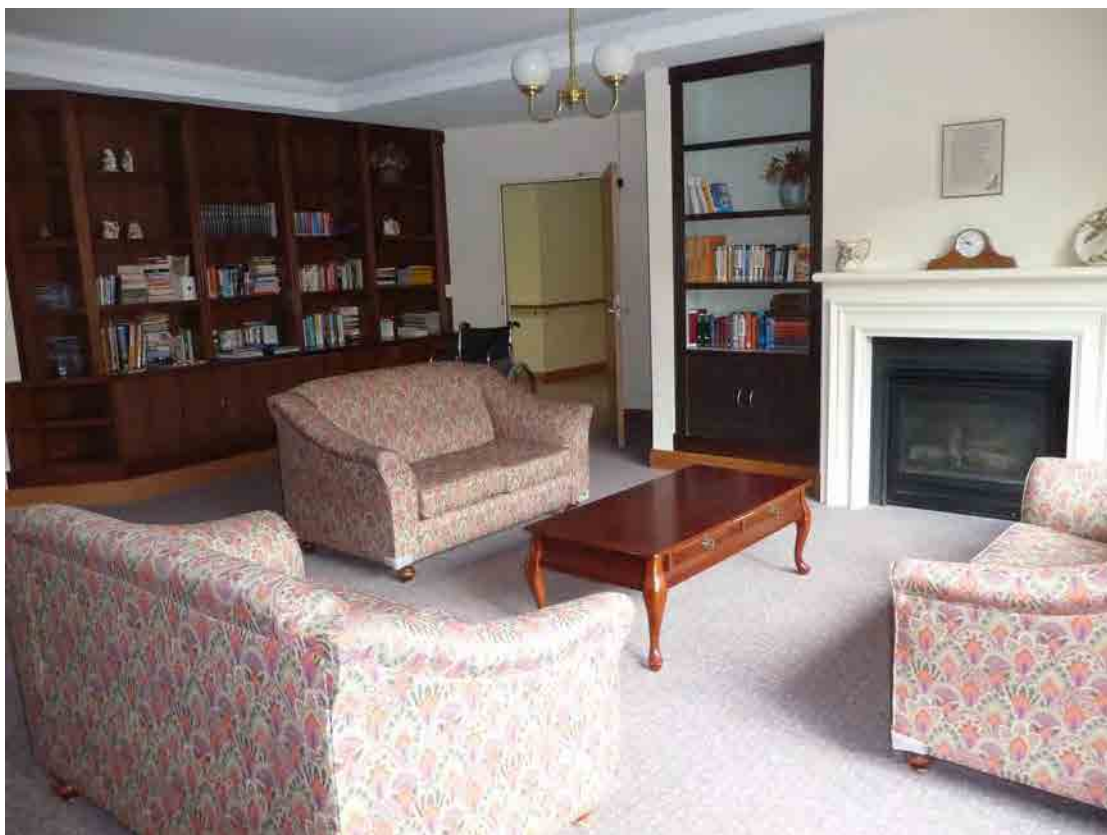
Recommendation 106 – private family areas

This room can provide a quiet retreat for reading or alternatively can accommodate private social interaction

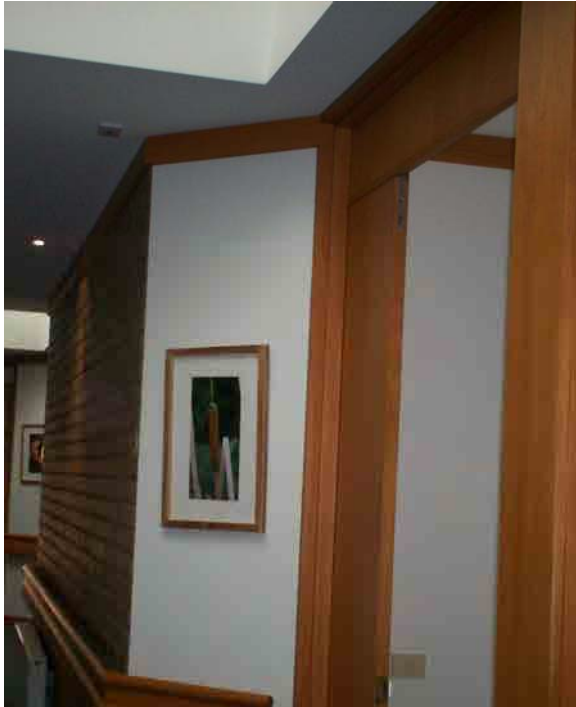
Recommendation 107 – entrances distinctive

- Each resident room has a distinctive picture next to their room door to assist in wayfinding.
- The hallway is created in such a way that each picture can be seen from a distance.
- Note however, the use of brick walls may be considered hazardous – especially behind the handrail.

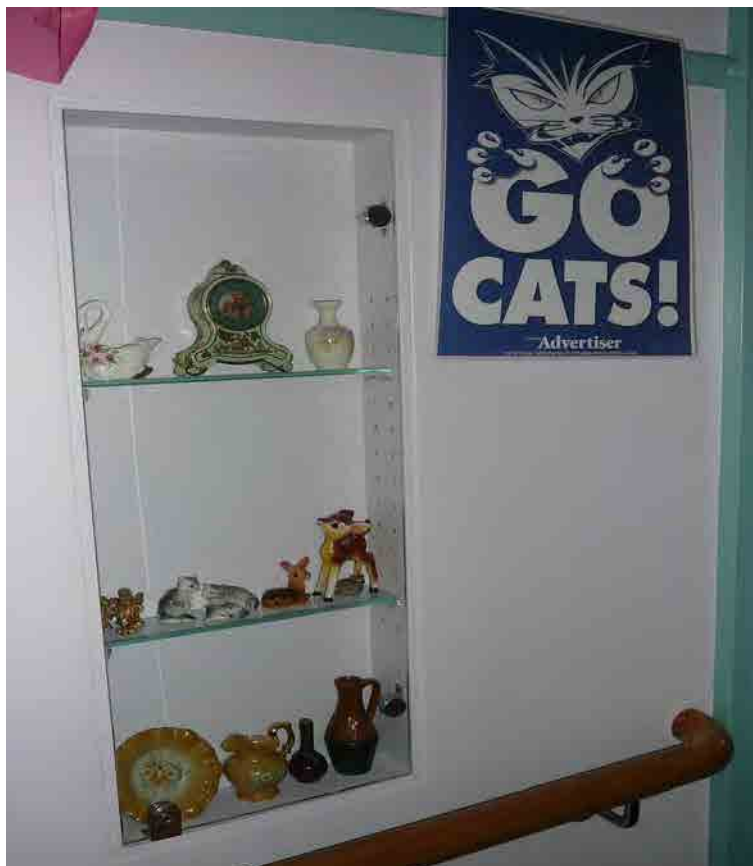
A glassed wall cabinet outside a resident's room:

- It creates a talking point, and can show off individual treasures.
- The poster also personalises the area, and provides a distinctive landmark for the resident.

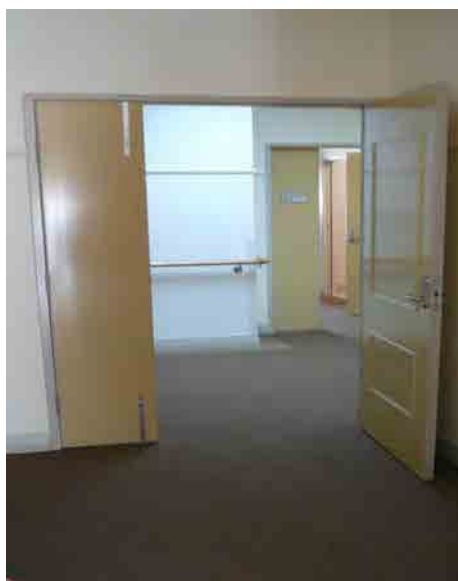
The room doorways are recessed and staggered along a hallway to promote privacy for the residents.

- This is an example of a “cat and mouse” door, with wood panelling.

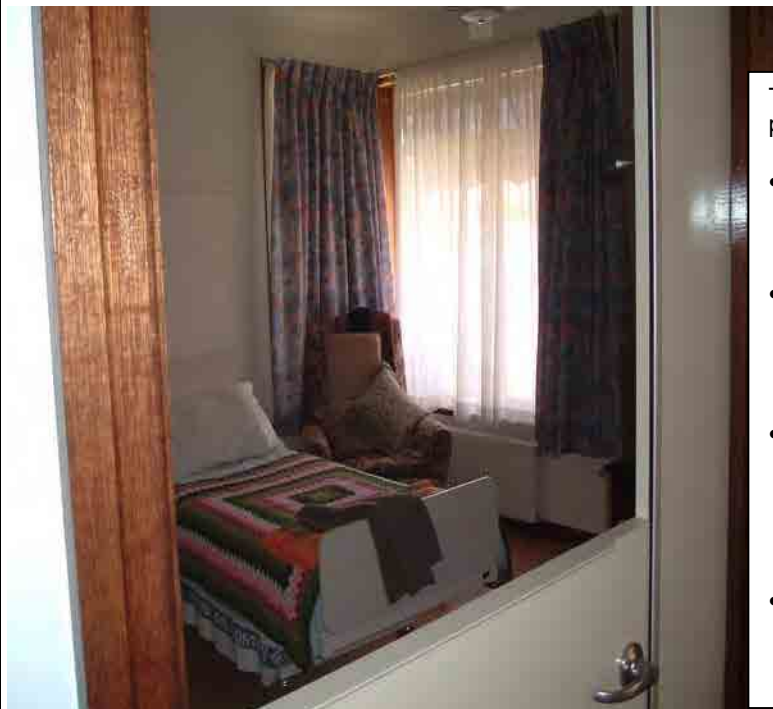
This type of entrance can affect privacy and dignity for the resident.

- This type of “barn” door may impede resident movement to and from their room.
- The location of the bed opposite the door means when the door is opened either fully or partially the bed is viewable.
- The position of the armchair is facing the hallway where the action is – but when the door is half closed it limits this hallway view.
- (NB: the door when divided into two must continue to meet fire regulations for egress.)

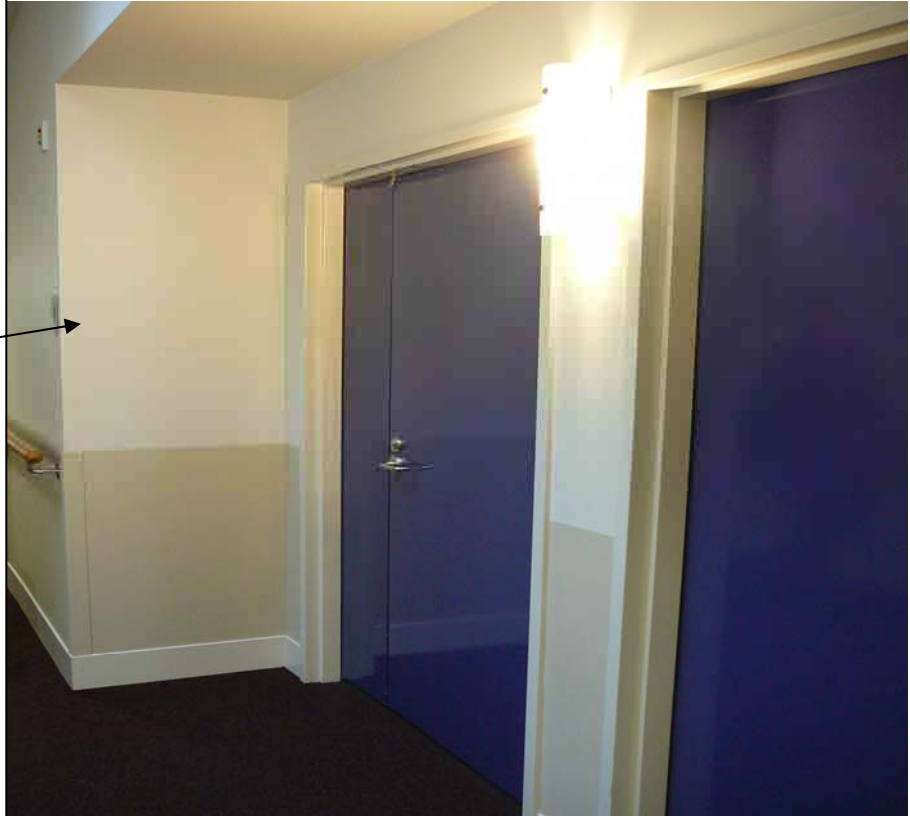
Recommendation 112 – door contrast (refer Rec.42 photo)

The resident room doors are recessed in the hallway side by side.

- They are painted the same colour (as are all the doors in this hallway) and have no further means of identification on them.
- There is a small number for identification on the hallway wall.
- Residents, staff and visitors get lost and wander into the wrong rooms.
- The doors stand out against the walls but the architraves and walls blend together.

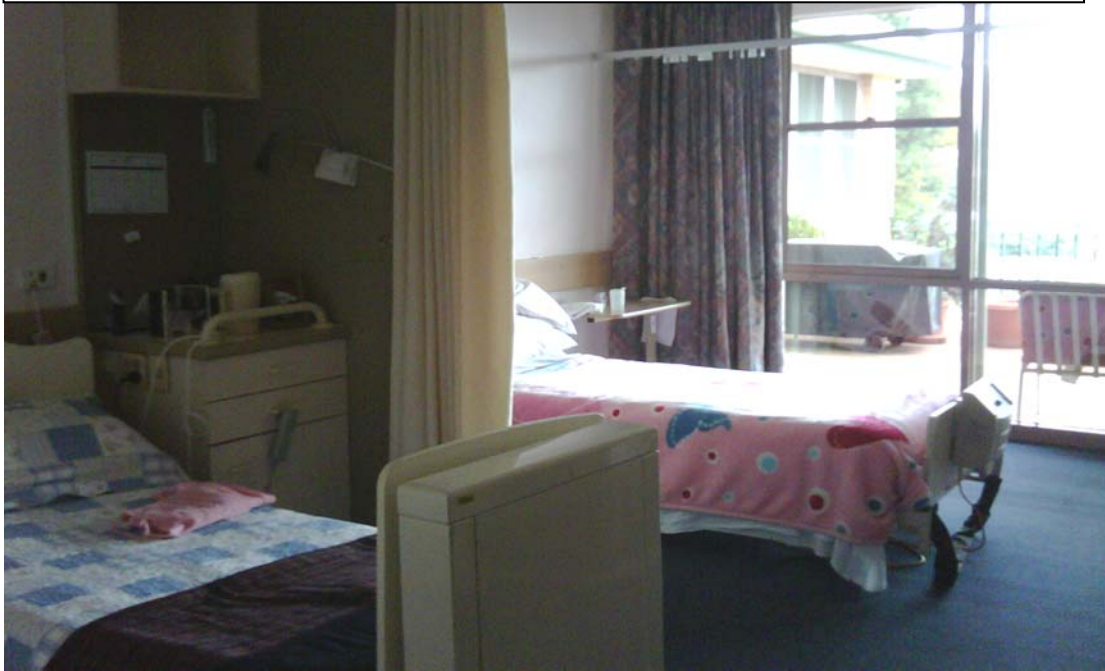
Recommendation 113 – shared bed room

The resident situated closest to the window has the access and the view. The other bed is positioned in such a way that it is difficult for the resident to see past the bed curtains.

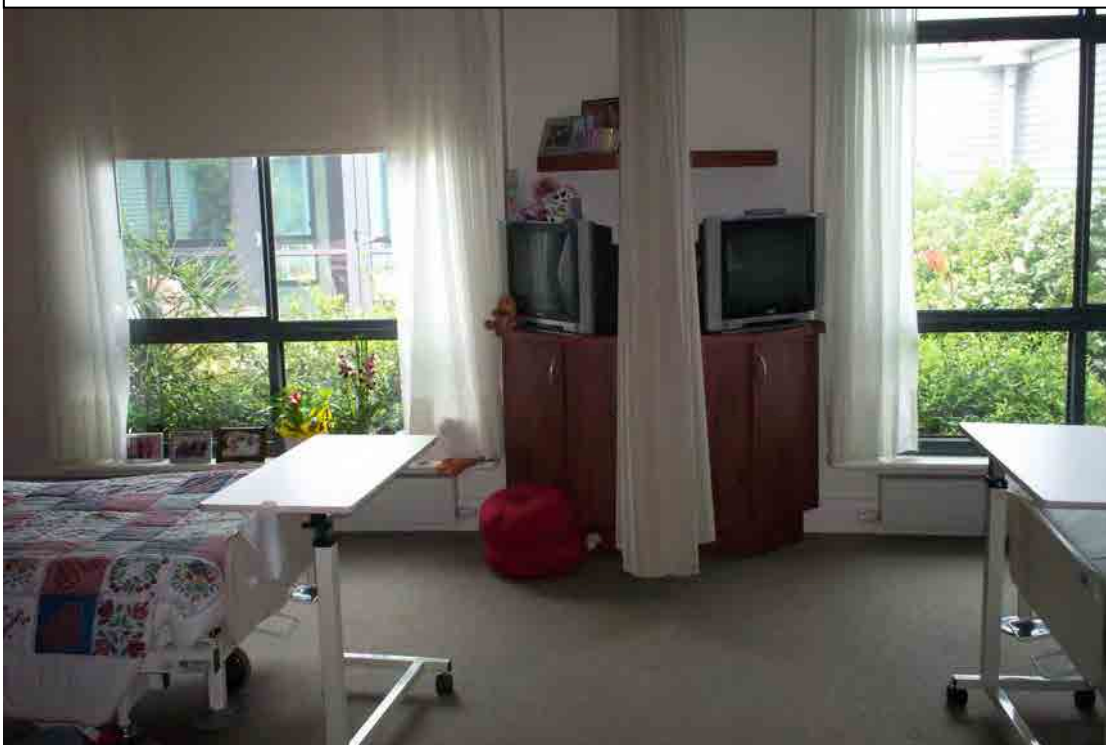
In this 2-bed room each resident has their own window access and therefore their own space. Note – one prefers the blind partially down, while the other resident prefers full light.

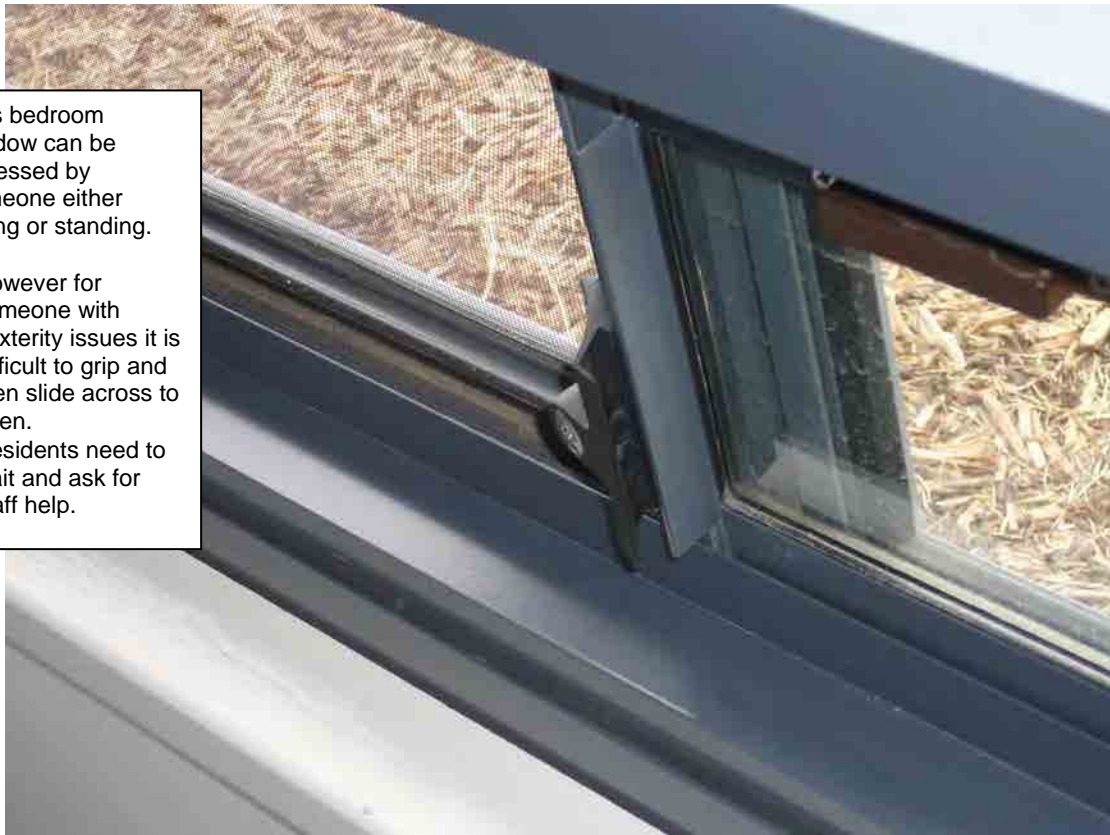
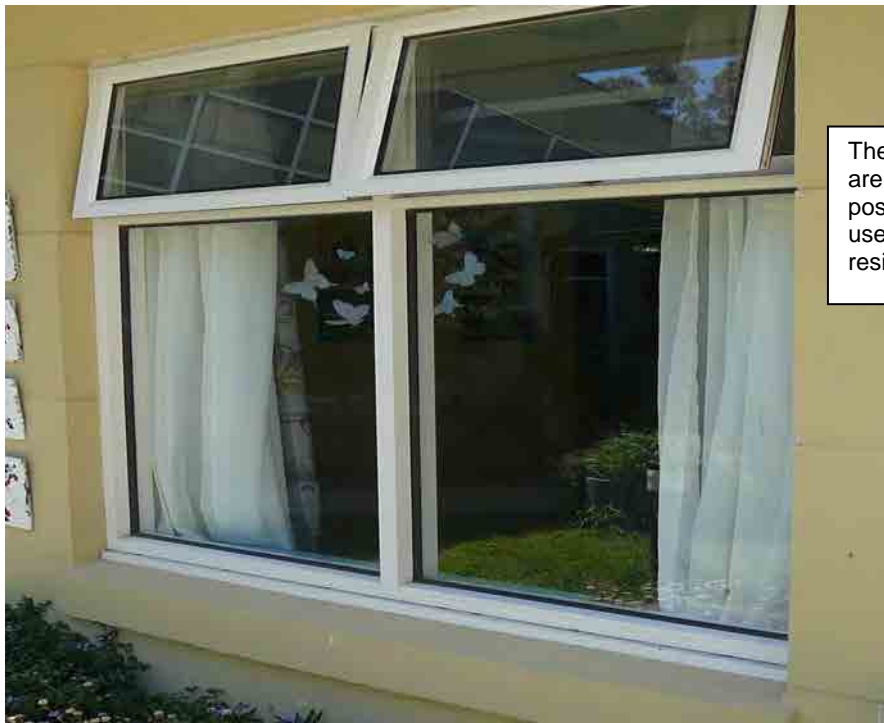
Recommendation 114 – windows (relevant to Rec. 44, 76)

- However for someone with dexterity issues it is difficult to grip and then slide across to open.
- Residents need to wait and ask for staff help.

The window winders are located in positions too high for users (staff and residents) to reach.

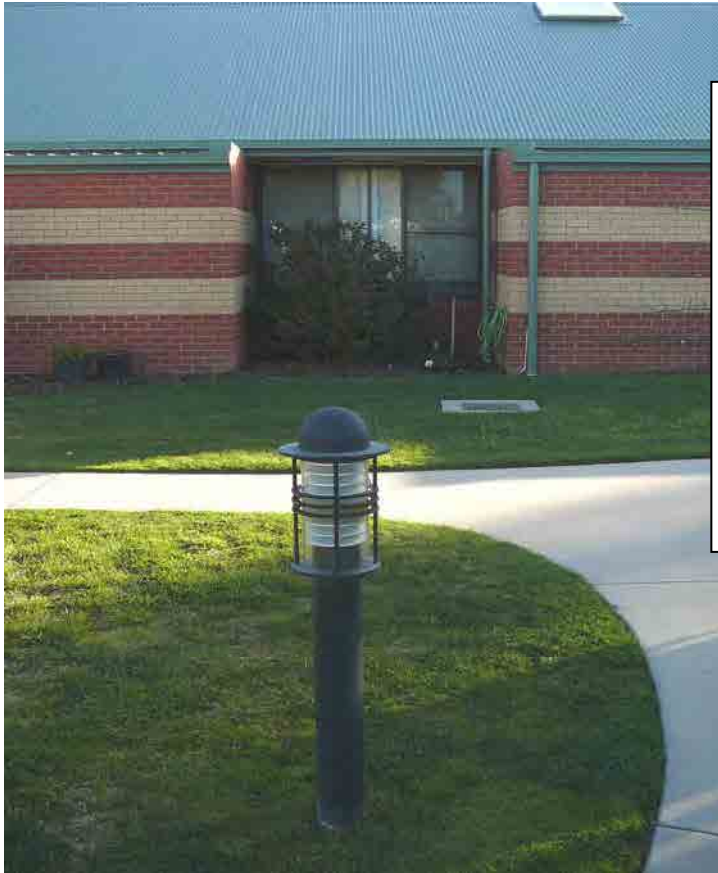
Recommendation 125 – glare (refer Rec. 55, 87 photos)

This external light shines directly into a resident's room at night.
It took a long time for the RACS to work out why the resident was not sleeping and so agitated at night.

- If you look closely you will see the block out paper that has been placed behind the curtains because they were not sufficient in blocking the light.
- Noted under Rec. 4

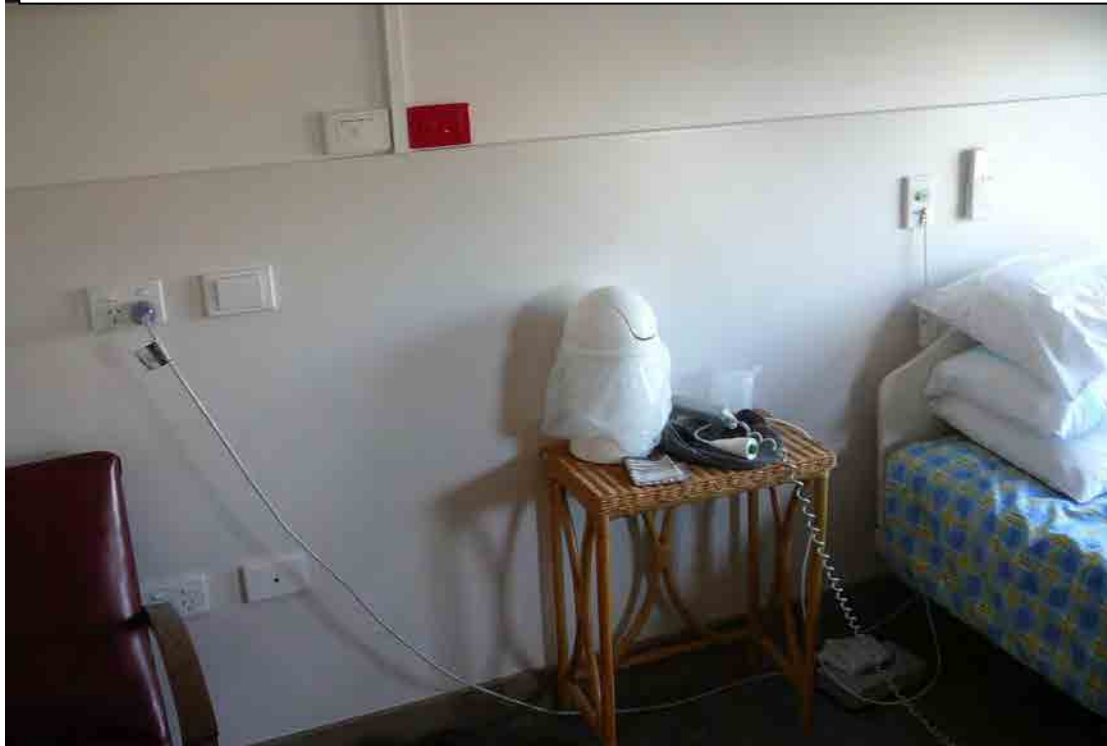
Recommendation 130 – power points

An example where the resident prefers their bed by the window, but unfortunately the 2 sets of power points are available in the middle of the room only.

In this facility power points are located close to the floor in resident rooms.

It was found when the bed was automatically lowered, it edged closer to the wall on descent and clipped the power point either turning it on or knocking the plug from the socket

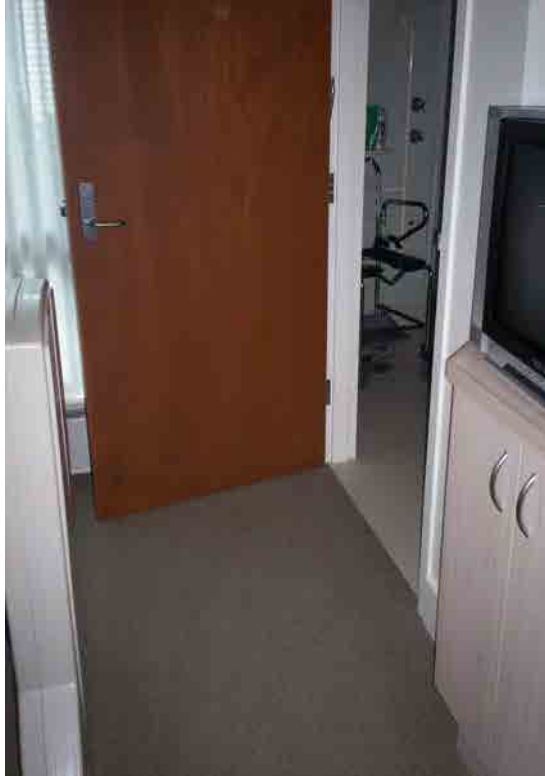
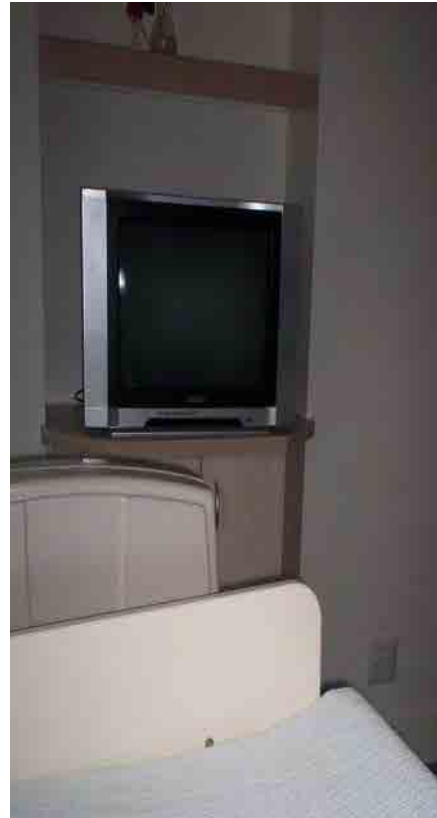
Recommendation 134 – bed appearance

This resident's room originally had a high- low bed which was replaced with a low low bed. The new bed created issues for the resident:

- When the bed was lowered the resident could not view the television in the alcove.
- The new bed was longer and therefore reduced the space between the bed and the wall making it difficult for the resident to navigate a wheelchair through the gap.

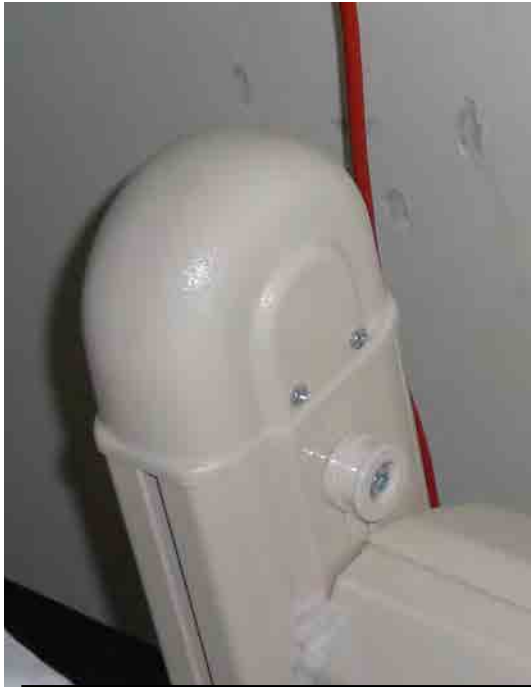
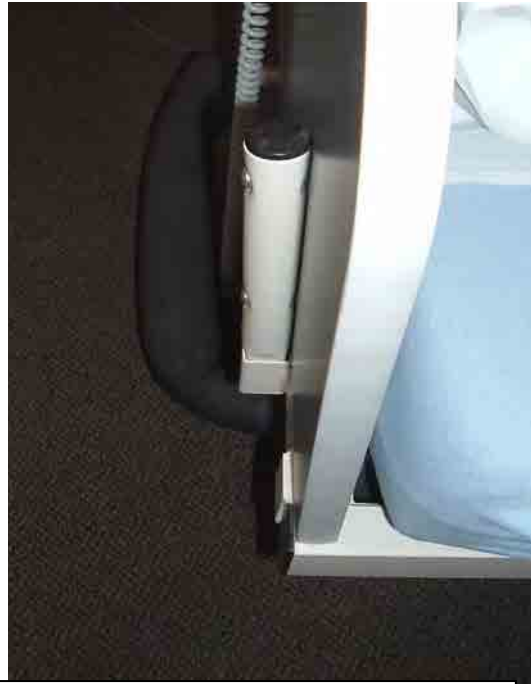
Recommendation 135 – bed protection

The picture on the left is from a bed that has to be moved forward each time to a position where the ceiling hoist can be used, but has no protection when moving back against the wall. The picture on the right shows a bed with built in protection.

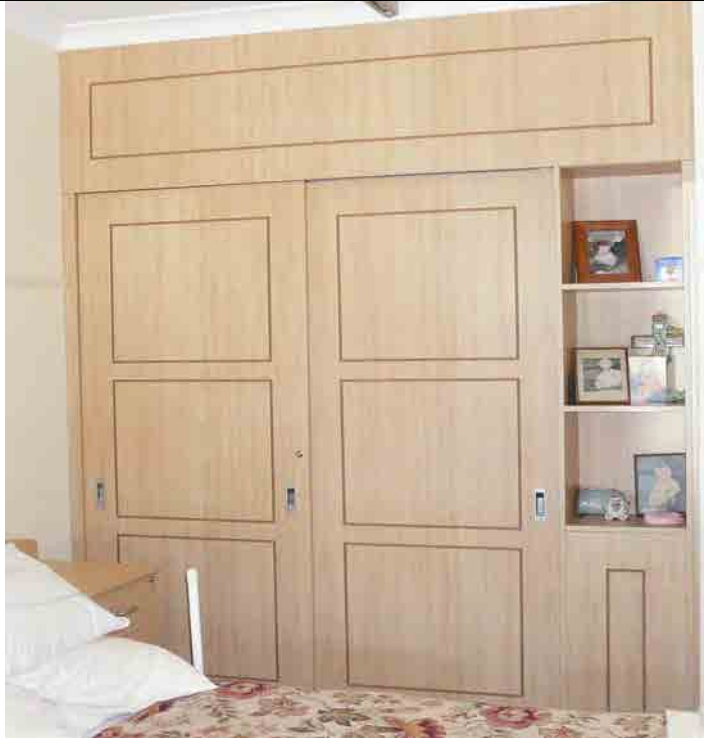
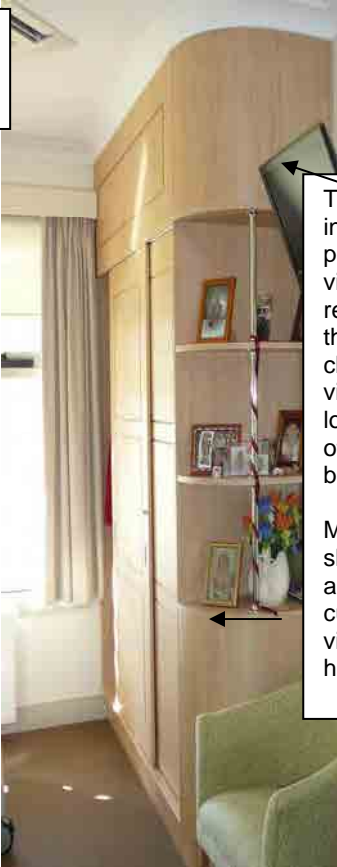
Recommendation 139 – wardrobe doors and drawers

Examples of wardrobes where there is ample storage for the resident and the wardrobe provides an attractive piece of furniture in the room.

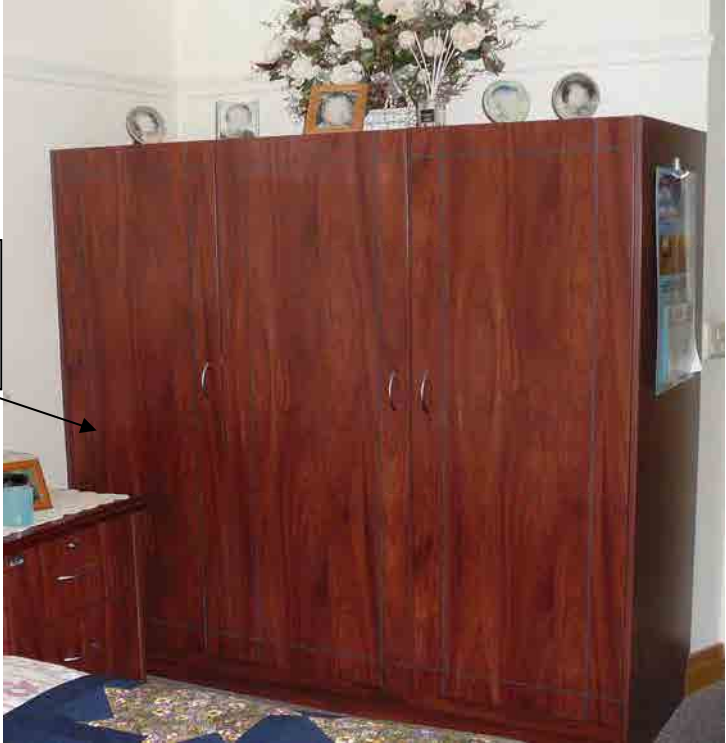
The television is in a poor position for viewing by the resident from the bed and the chair (not visible) is located on the other side of the bed.

Mementoes on shelves provide a wayfinding cue which is visible from the hallway.

Note the wardrobe is large enough, but one door is hindered by the position of the bedside drawers.

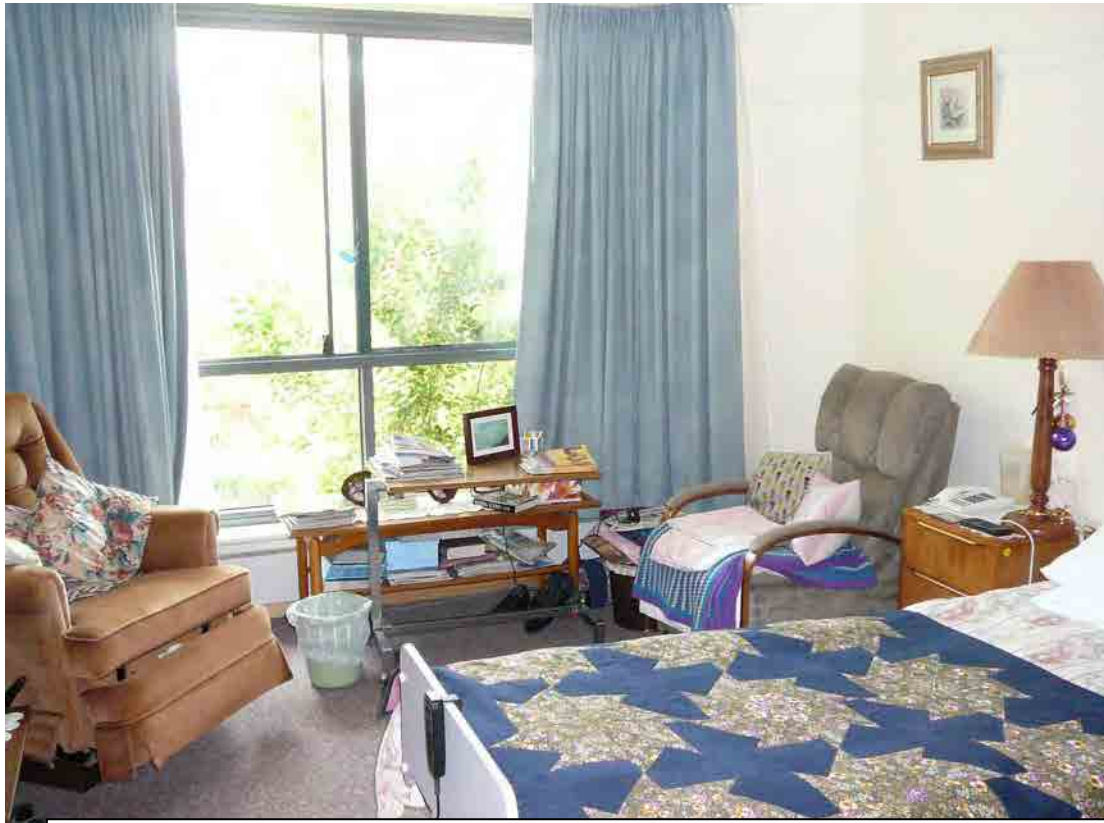
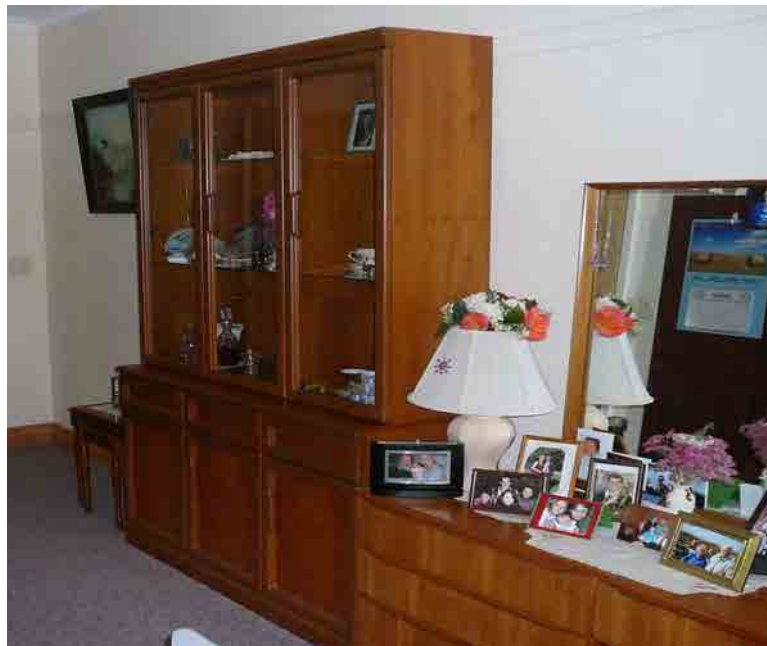
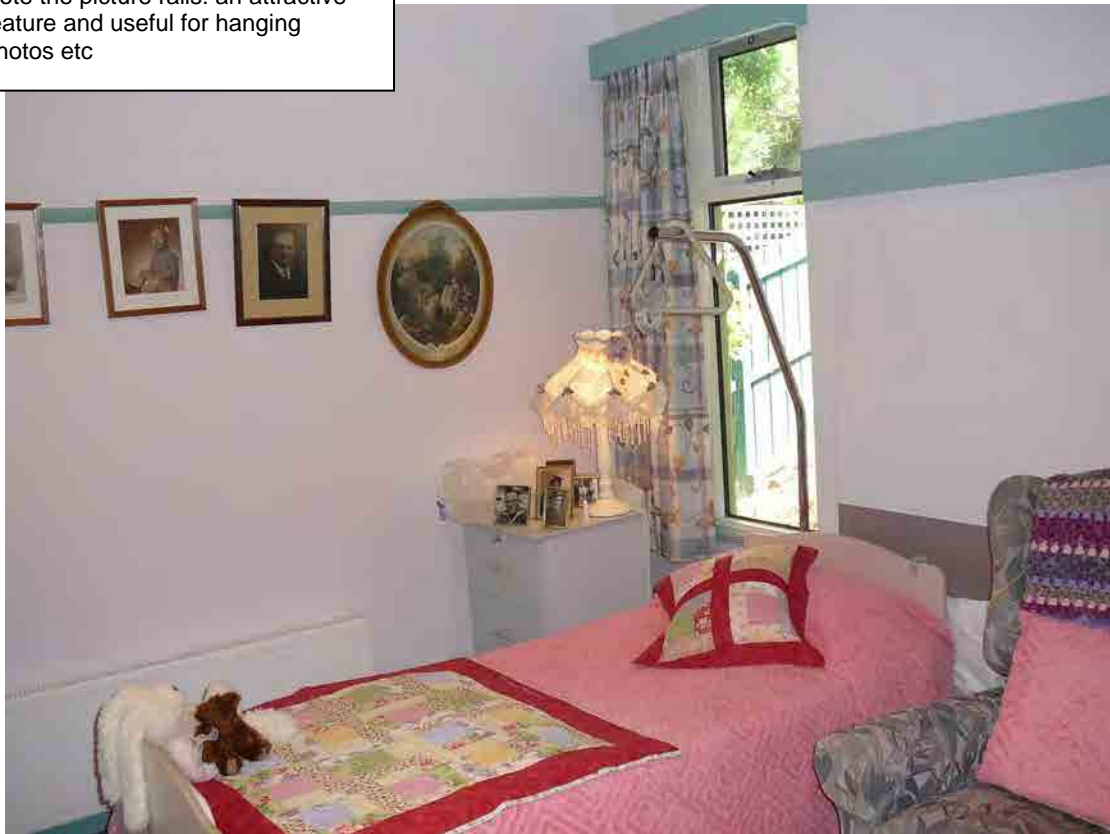
Recommendation 143 – personal belongings

Examples of resident rooms where personal belongings are encouraged.

Note the picture rails: an attractive feature and useful for hanging photos etc
