Residential aged care services built environment audit tool

Online version 1.2: Part 5. Photo gallery

5. Photo gallery

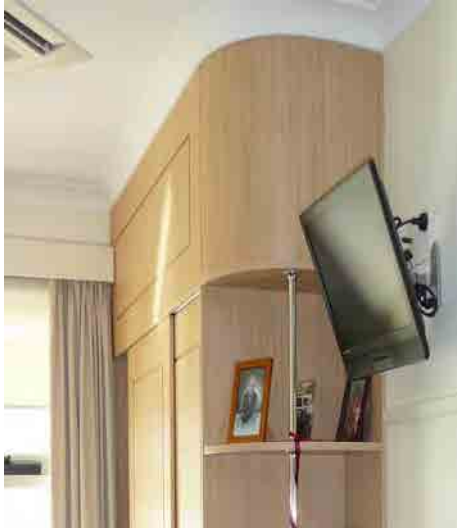
Recommendation 149 – television position

- The resident needs to crane their neck to look up at this television.
- There is a chair to the left of the bed, but the television cannot be viewed completely from the chair because the wardrobe is in the way.

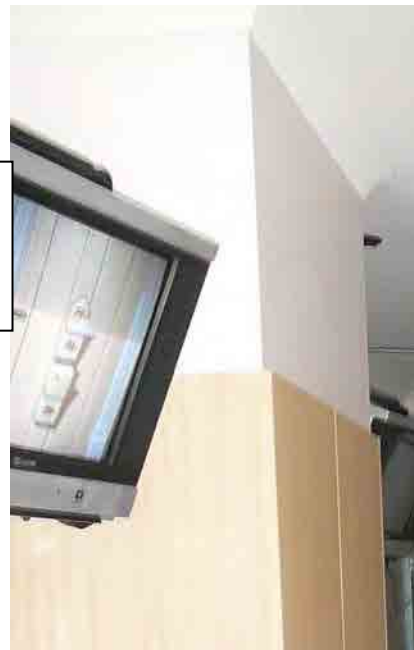
The television is not in the best position, but is also hampered by the glare from the window beside it.

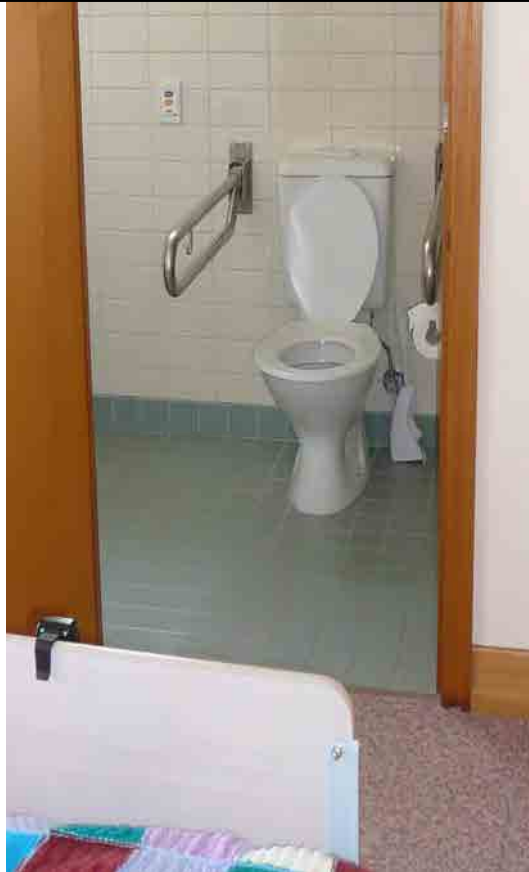
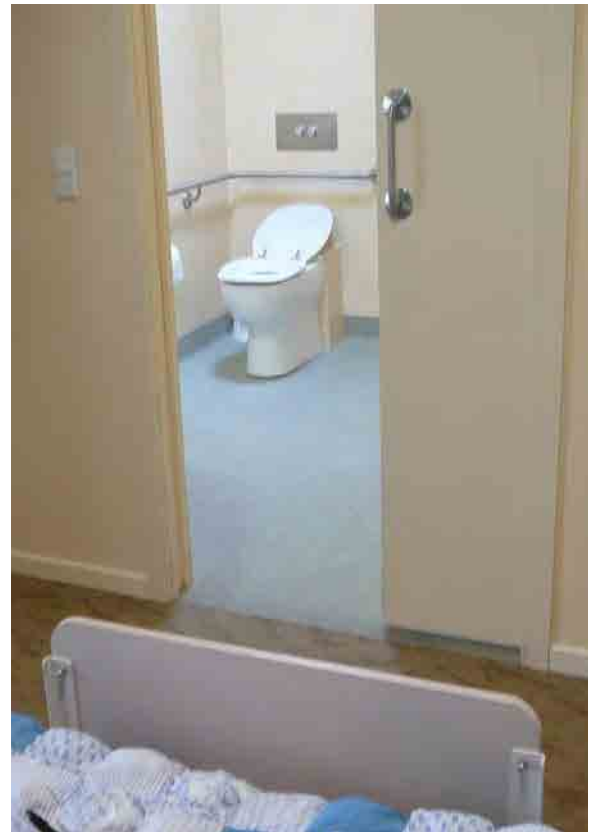
Recommendation 153 – bed/toilet view

Research has proven that a view of the toilet from the bed will encourage residents to use it.

- The left picture shows an ensuite door, that when left open, impacts on the walkway from one side of the bed.
- The picture on the right shows an ensuite with a sliding door.

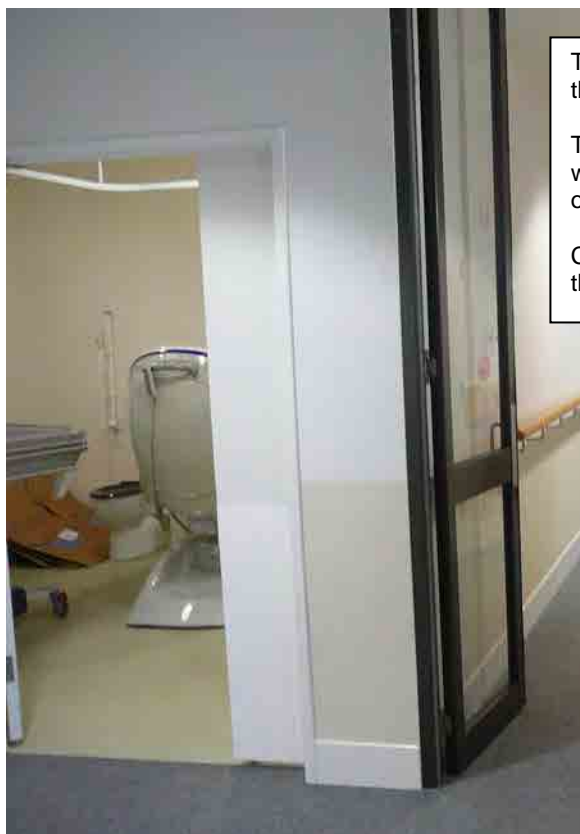
Recommendation 158 – bathroom privacy

This bathroom is situated in an alcove to the left of the main thoroughfare.

The bath and toilet are clearly visible from the walkway, reducing resident privacy when the door opened.

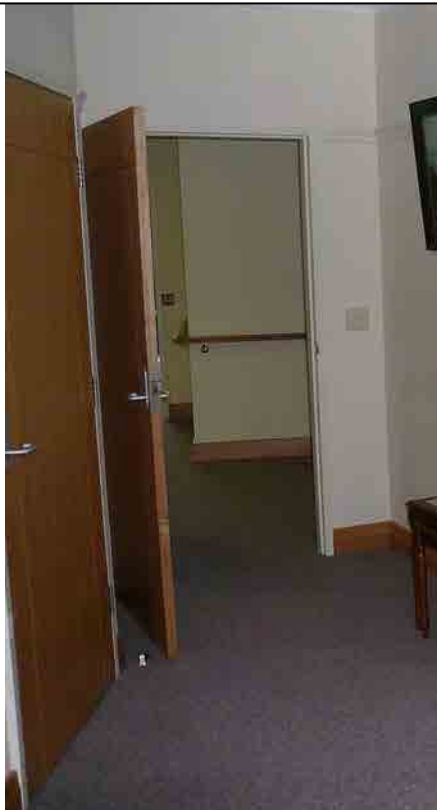
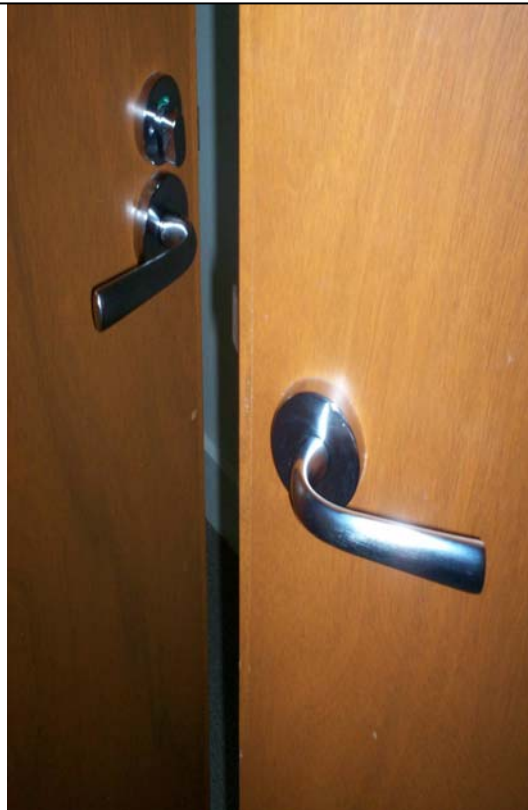
Recommendation 166 – doors opening (refer Rec.70 photo)

- (Below) 2 examples of the resident's room entry door clashing with the ensuite door when both are opened. Thus when entering, the room door needs to be closed before the ensuite door can be opened.

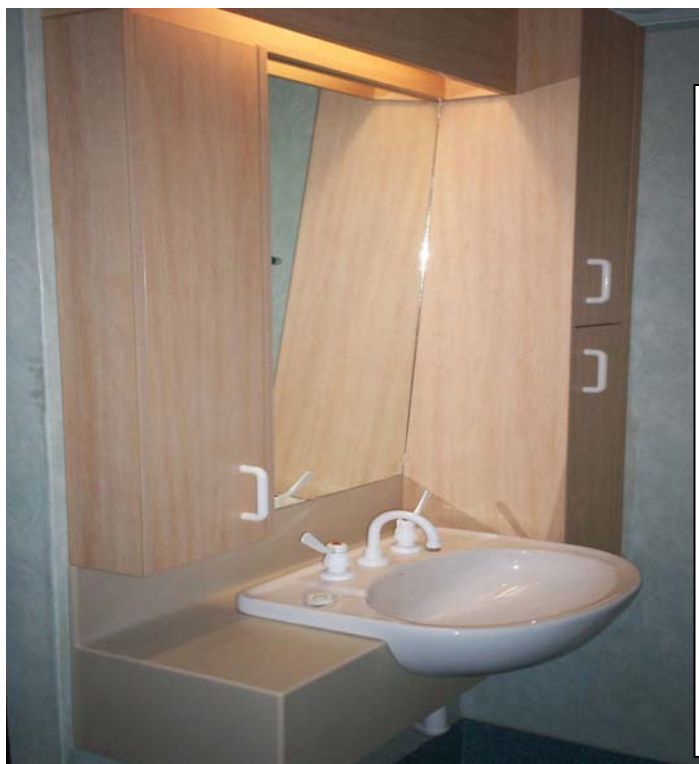
Recommendation 180 – toilet storage

- The basin stands out from the walls and floor.
- It provides an attractive fixture in the ensuite.
- It is well lit and has a large mirror above the basin.
- The mirror tilts forward so reduces glare from the overhead light.
- It also has sufficient storage space for toiletries as well as incidentals which may be used by staff.
- There is no need to bend to access items.

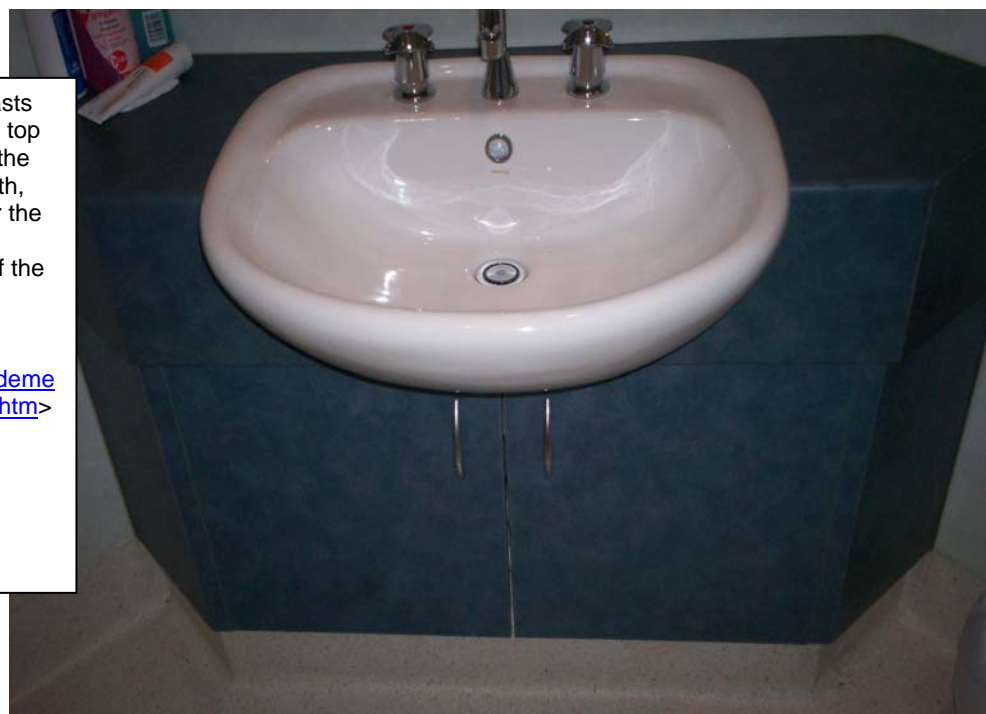
(Below) The basin contrasts clearly against the bench top and cupboard. However the only storage is underneath, which means bending for the resident – so notably, toiletries remain on top of the bench for easy access.

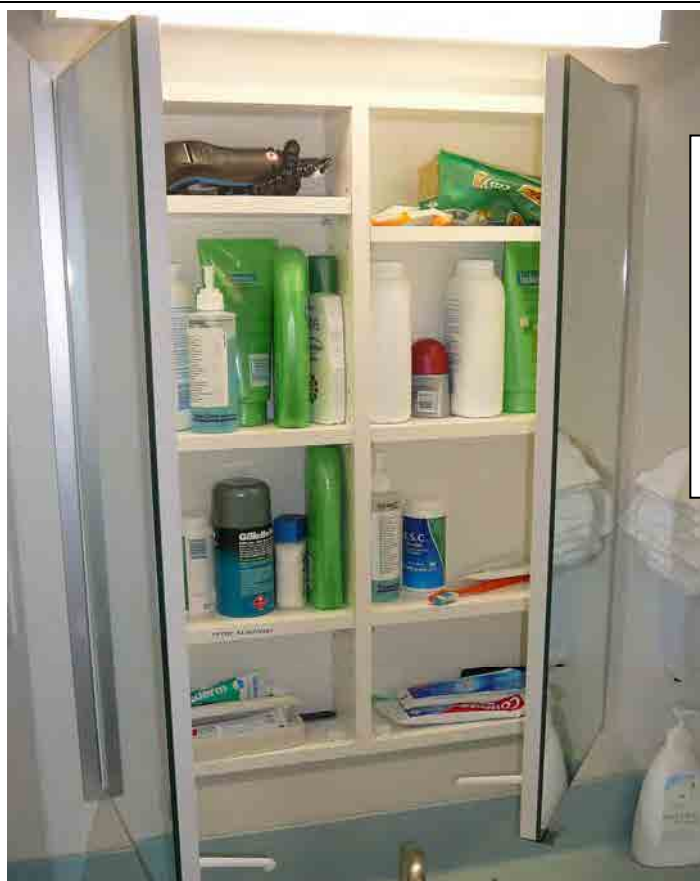
2 residents share an ensuite and one cupboard with separate partitions.

- Their individual personal items are regularly mixed up by residents, staff and family.
- Colour coding the shelves each side may contribute to defining each area.

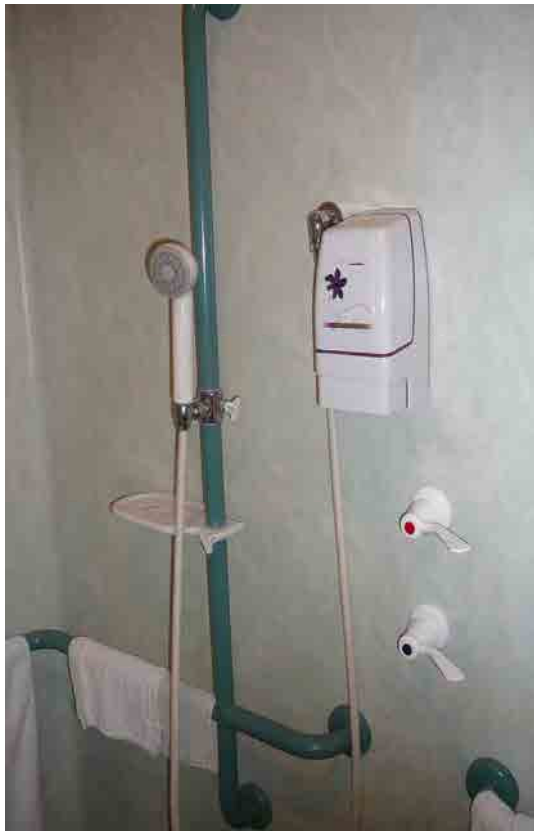
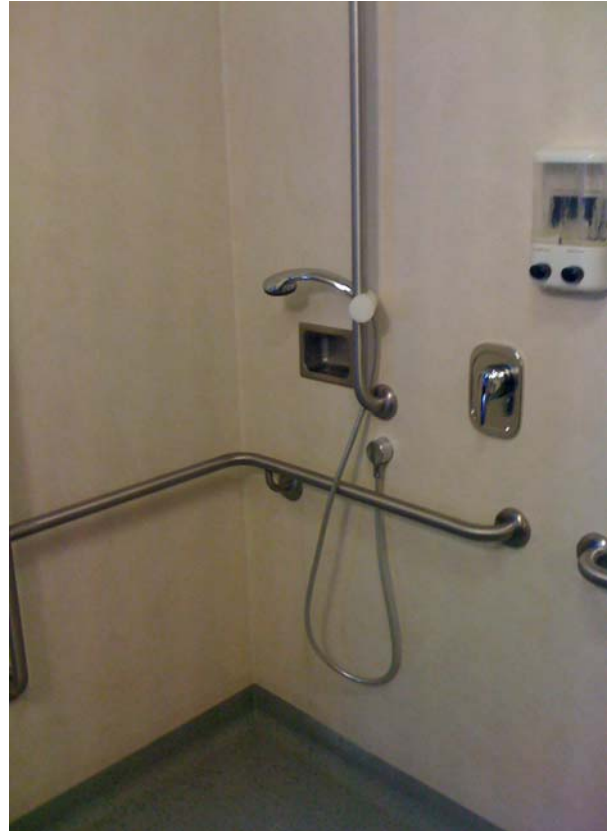
Recommendation 181 – shower fittings

- Residents have found these levers difficult to operate in some instances, as they are not readily recognisable.
- Both photos have fittings that contrast with the walls and floor.

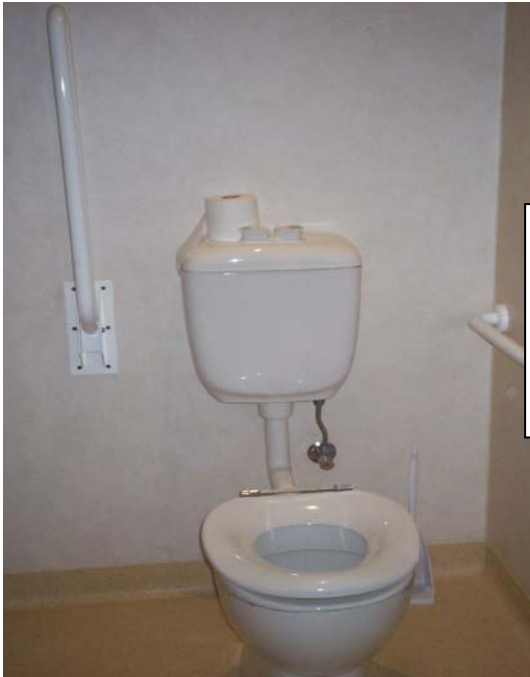
Recommendation 190 – toilet contrast

A white toilet with white grab rails on a light background can be difficult to see.

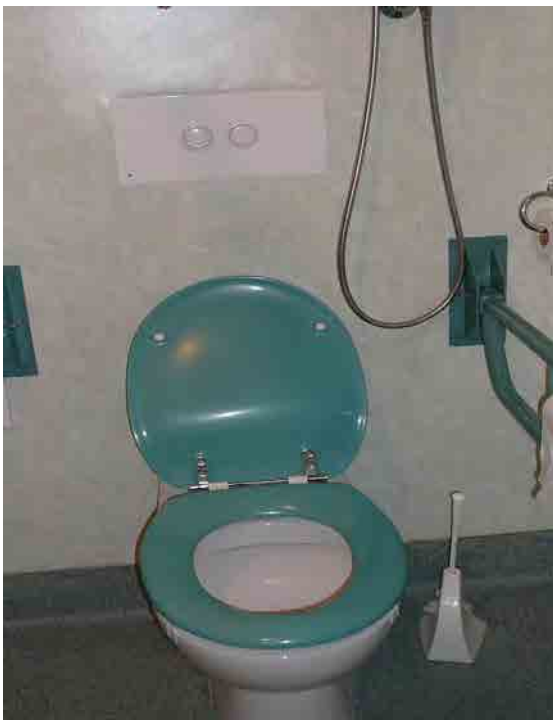
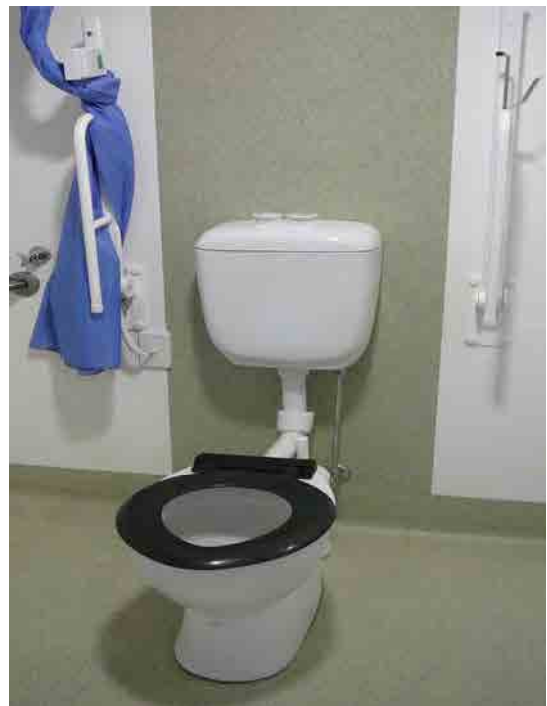
Examples of toilets contrasting with the background,

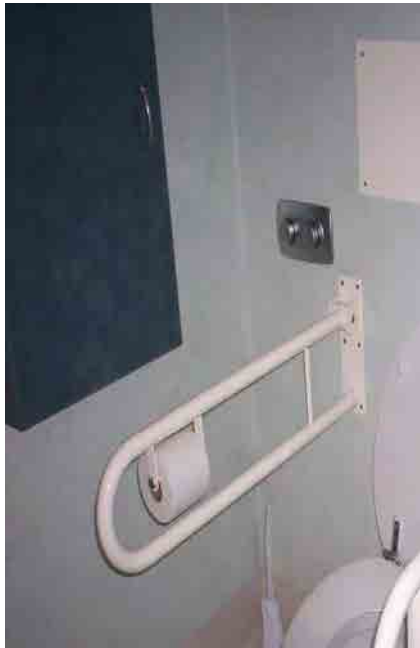
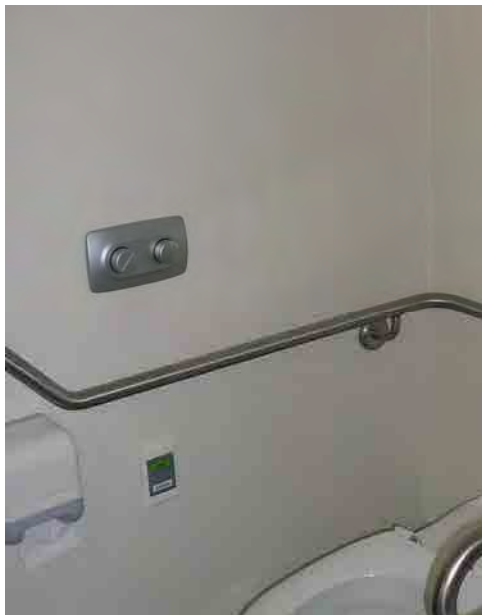
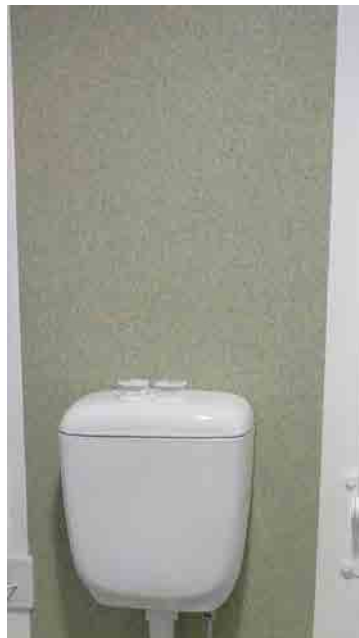
Recommendation 191 – toilet flush buttons

Examples of buttons used across RACS. The buttons should be easily accessed by residents and other users.

- The bottom right picture shows the traditional cistern which residents would be more familiar with, rather than buttons in various positions on a wall.
